File In Section: Product Recalls
Bulletin No.: 10243
Date: August 2010

Recall Bulletin

SUBJECT: Second Row Safety Belt Interference When Seat Back Returned to Upright Position

MODELS: 2009-2010 Buick Enclave
2009-2010 Chevrolet Traverse
2009-2010 GMC Acadia
2009-2010 Saturn OUTLOOK

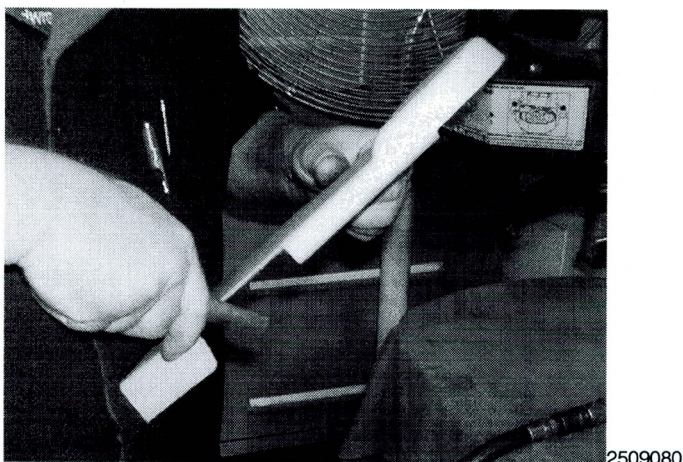
2509079

Note: Maintain the original notch out width (1) of approximately 82 mm (3.230 in) and remove the material until the surface edge is even with the vertical wall surface (2).

5. After the material has been removed, file down any jagged edges or corners that may tend to snag the buckle material.
6. Reinstall the rear seat recliner inner trim cover. Refer to *Rear Seat Recliner Outer Finish Cover Replacement - Inboard* in SI.
7. After the rework and installation of the trim cover, verify proper function of the seat assembly.
8. Complete the rework on the trim cover for the opposite seat.
