# Recall Bulletin

## PRODUCT SAFETY RECALL

**SUBJECT:** Second Row Safety Belt Interference When Seat Back Returned to Upright Position

**MODELS:** 2009-2010 Buick Enclave  
 2009-2010 Chevrolet Traverse  
 2009-2010 GMC Acadia  
 2009-2010 Saturn OUTLOOK

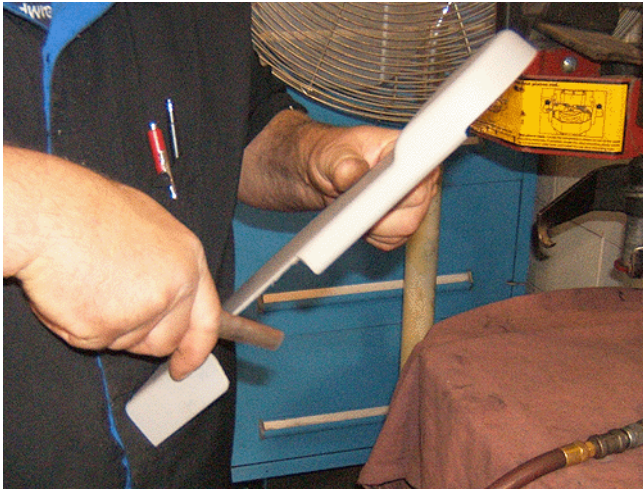
2509079

Your vehicle may have a condition where the second row seat side trim shield restricts the upward rotation of the safety belt buckle when the seat back is returned to a seating position after being folded flat. If the buckle contacts the seat frame, additional effort is required to return the seat to a seating position. If sufficient force is applied, the buckle cover could be pushed down the strap, exposing and partially depressing the red release button. As a result, the release button will not travel as much as designed when depressed and will appear to be jammed. The buckle cover may have visible damage which may only be cosmetic, but in some cases, the buckle may not latch/unlatch, or may appear to latch when the latch mechanism is not fully engaged. As a result, the safety belt may not restrain the occupant as intended during a crash, which could result in injury to the occupant.

**Note:** Maintain the original notch out width (1) of approximately 82 mm (3.230 in) and remove the material until the surface edge is even with the vertical wall surface (2).

5. After the material has been removed, file down any jagged edges or corners that may tend to snag the buckle material.
6. Reinstall the rear seat recliner inner trim cover. Refer to *Rear Seat Recliner Outer Finish Cover Replacement - Inboard* in SI.
7. After the rework and installation of the trim cover, verify proper function of the seat assembly.
8. Complete the rework on the trim cover for the opposite seat.
