HYUNDAI Technical Service Bulletin

Group	CAMPAIGN
Number	10-01-032
Date	SEPTEMBER, 2010
Model	2011 SONATA (YF)

Subject **STEERING COLUMN INTERMEDIATE SHAFT CONNECTIONS INSPECTION (CAMPAIGN 097)**

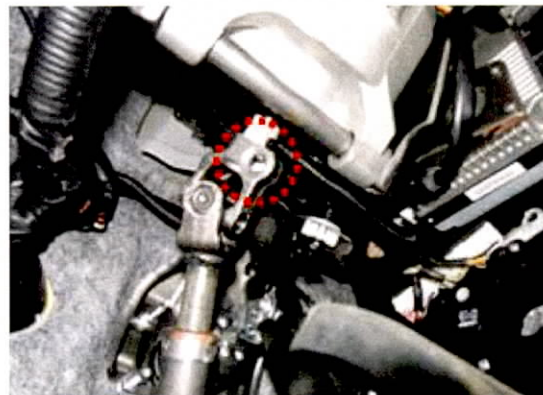
4. Remove the steering column-to-U joint bolt.

5. Inspect the bolt for damage/ stripping/cross-threading. Inspect the corresponding threads in the U-joint. Replace both if damage is found.

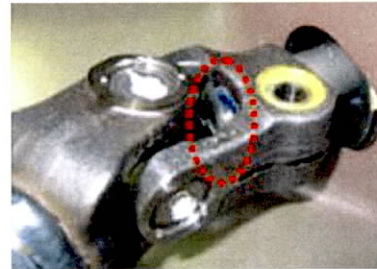
5. Remove the steering column-to-U joint bolt.

6. Inspect the bolt for damage/ stripping/cross-threading. Inspect the corresponding threads in the U-joint. Replace both if damage is found.
