RE: NHTSA Recall 10V-426, Hyundai Recall 097

SUBJECT: Recall Campaign 097 - 2011 MY Sonata Steering Column Intermediate Shaft Connections Inspection - TSB# 10-01-032-1

Group	CAMPAIGN
Number	10-01-032-1
Date	OCTOBER, 2010
Model	2011 SONATA (YF)

Subject STEERING COLUMN INTERMEDIATE SHAFT CONNECTIONS INSPECTION (CAMPAIGN 097)		Date OCTOBER, 2010	
		Model 2011 SONATA (YF)	
CIRCULATE TO:	<input type="checkbox"/> GENERAL MANAGER	<input checked="" type="checkbox"/> PARTS MANAGER	<input checked="" type="checkbox"/> TECHNICIAN
<input checked="" type="checkbox"/> SERVICE ADVISOR	<input checked="" type="checkbox"/> SERVICE MANAGER	<input checked="" type="checkbox"/> WARRANTY MGR	<input type="checkbox"/> SALES MANAGER

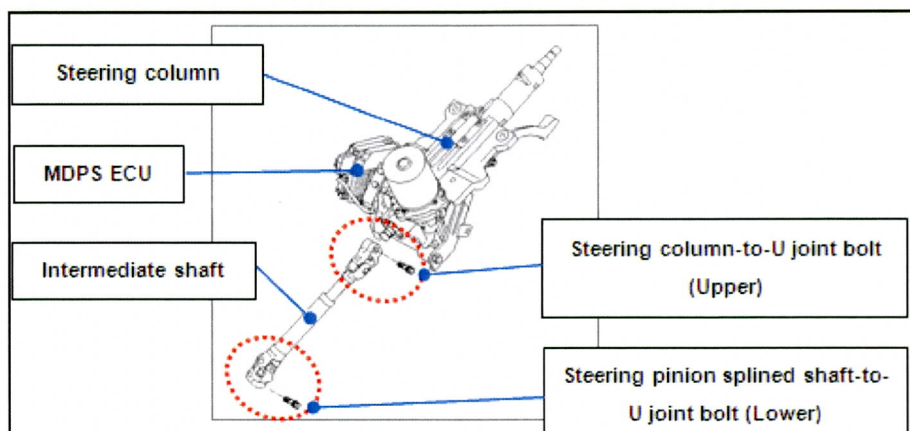
This bulletin provides the recall Campaign 097 procedure for inspecting to ensure that the steering column and the upper intermediate shaft universal joint (U joint), and the steering pinion splined shaft and the lower intermediate shaft U joint are properly connected and that both attaching bolts are tightened to the specified torque.

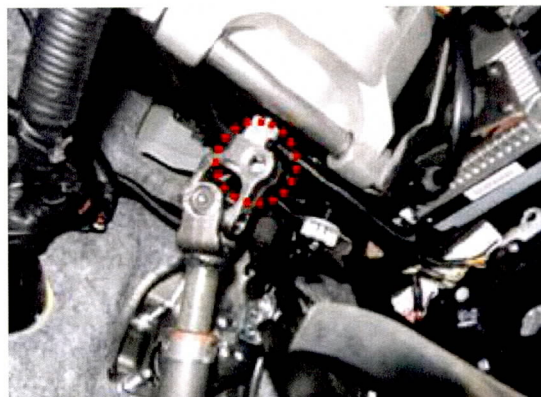
5. Inspect the bolt for damage/ stripping/cross-threading. Inspect the corresponding threads in the U-joint. Replace both if damage is found.

4. Remove the steering column-to-U joint bolt.

NOTE: If the bolt and intermediate shaft are replaced, submit a claim (in addition to the campaign claim) under normal warranty.

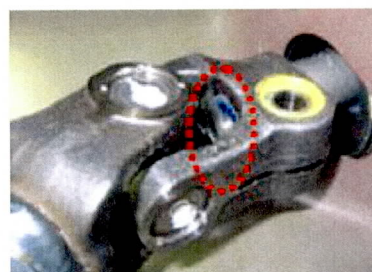
6. Inspect the bolt for damage/ stripping/cross-threading. Inspect the corresponding threads in the U-joint. Replace both if damage is found.

5. Remove the steering column-to-U joint bolt.

NOTE: If the bolt and intermediate shaft are replaced, submit a claim (in addition to the campaign claim) under normal warranty.
