Campaign Service BULLETIN

BULLETIN NUMBER:
SB10-11-S002B

Regional Safety Recall 10V-436

Corrosion Affecting the Forward Mounting Point for Rear Suspension Lower Link Brackets

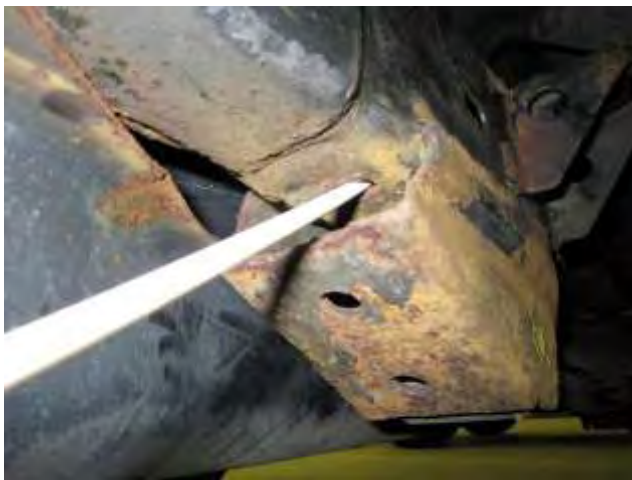
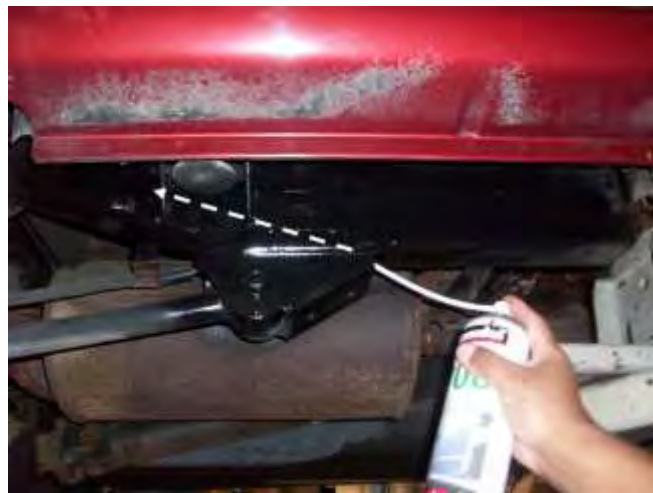
Figure 8 - Drain Hole

Figure 9 - Nozzle path 300mm

7. Insert the long spray nozzle with NOXUDOL 700 into the drain hole located on the bottom of frame up to the 300mm (12 inches) mark. Then spray NOXUDOL 700 while drawing out the nozzle. Spray two times. See Figures 8 and 9.

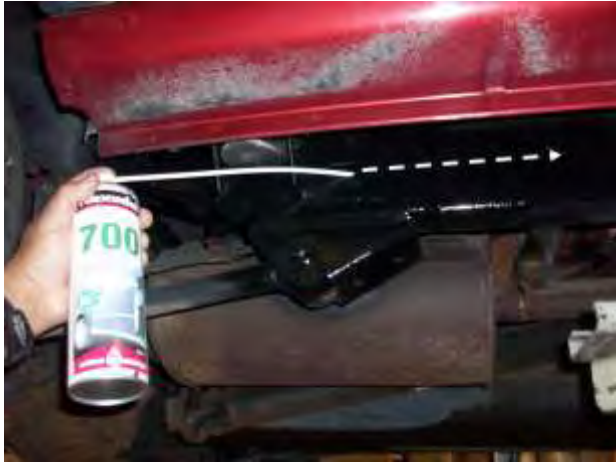
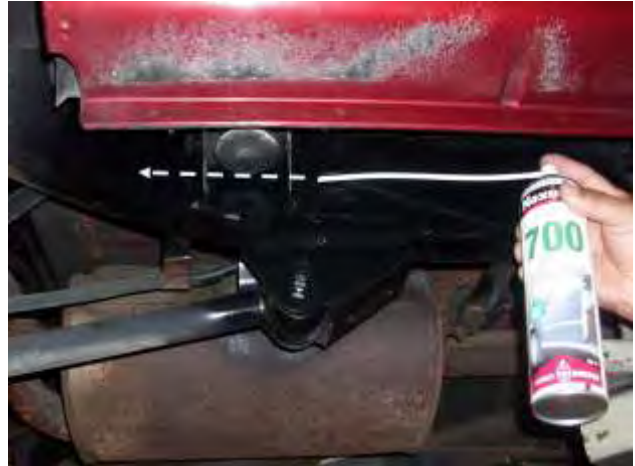
Figure 10 - Frame Hole toward front 300mm

Figure 11 - Frame Hole toward rear 300mm

8. Insert the long spray nozzle with NOXUDOL 700 into the side frame hole toward the front of the vehicle up to the 300mm (12 inches) mark. Then spray NOXUDOL 700 while drawing out the nozzle. Spray four times. See Figure 10.
9. Insert long spray nozzle with NOXUDOL 700 into the side frame hole toward the rear of the vehicle up to the 200m (7 inches) mark. Then spray NOXUDOL 700 while drawing out the nozzle. Spray four times. See Figure 11.

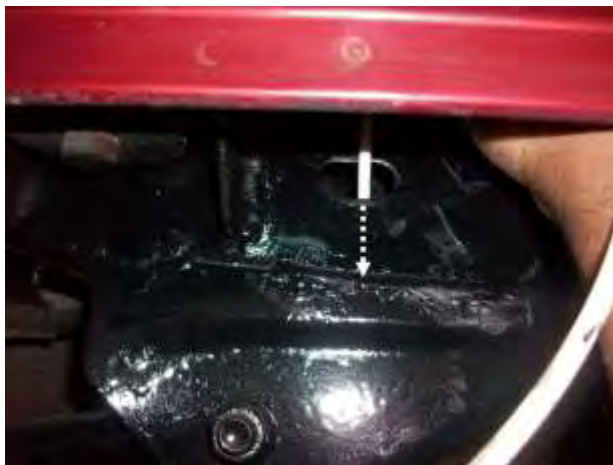
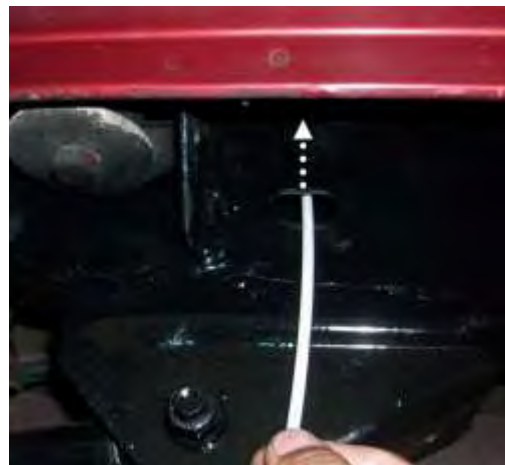
Figure 12 - Frame Hole down

Figure 13 - Frame Hole up

10. Insert long spray nozzle with NOXUDOL 700 through the side frame hole up and down. See Figures 12 and 13. Then spray NOXUDOL 700 with drawing out the nozzle. Spray two times in each direction.
11. Switch from the long spray nozzle to the short spray valve shown in Figure 7 and spray one coat of Noxudol 700 onto the outside of both driver and passenger side in the area indicated in Figure 4. Be careful not to overspray onto the exhaust system or body painted areas.
12. Using the short spray nozzle, spray Noxudol 300 onto both driver and passenger side as indicated in Figures 4 and 5. Be careful not to overspray onto the exhaust system or body painted areas.

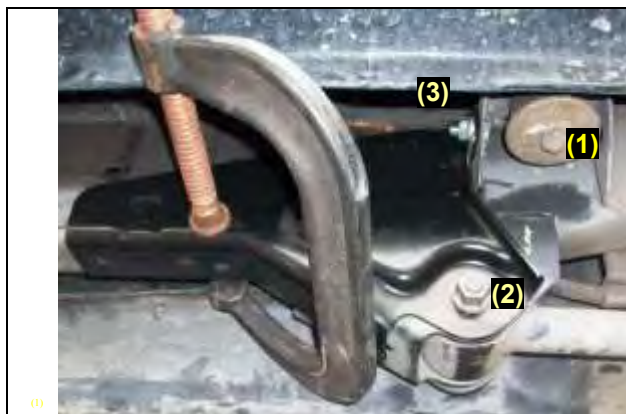
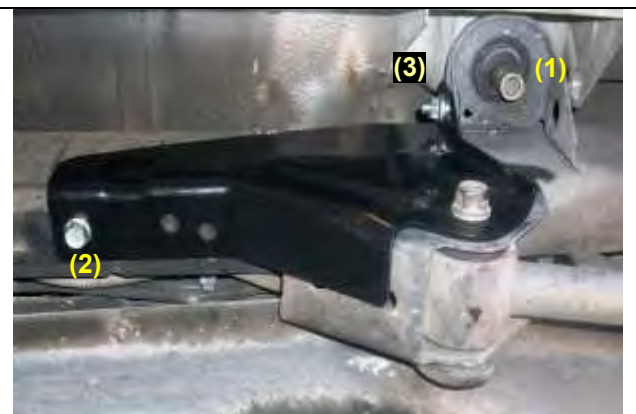
Figure 15: Driver side temporary installation (1998-

Figure 16: Driver side temporary installation (2000

2000 models) <ol style="list-style-type: none"> 1. # 4 body mount. 2. Trailing link mounting nut. 3. Stud and nut 	– 2002MY only <ol style="list-style-type: none"> 1. # 4 body mount lower half removed. 2. Weld nut already in frame for some 2000MY vehicles and all 2001 through 2002MY vehicles 3. Stud and nut
--	--

1. Remove the Rear Trailing Link Front Mount mounting nut from both driver and passenger side. See Figure 15.
2. Remove lower half of body mount # 4 from both driver and passenger side. See Figures 15 and 16.
3. Using a ratcheting strap, lash up the rear axle. Start by attaching one end of the strap to the upper link mount. Then route the strap around the rear axle, taking care not to cover any brake piping, and continue forward under the vehicle, attaching the other end of the strap to the transmission mount cross member. Apply enough forward tension on the rear axle to allow the lower link mounting bolt to be moved by hand (see Figure 14).

4. Using a hammer, knock on the outside of the frame rail to loosen any rust on the inside of the frame.
5. Using a wire brush and scraper remove any loose coating material, welding splatter and rust from the outside frame and rear lower trailing link front mounting bracket area on both driver and passenger sides.
6. Temporarily install both Type “A” reinforcement brackets using the original lower link mounting nut, “C” clamp and new stud and nut. See Figures 15 and 16

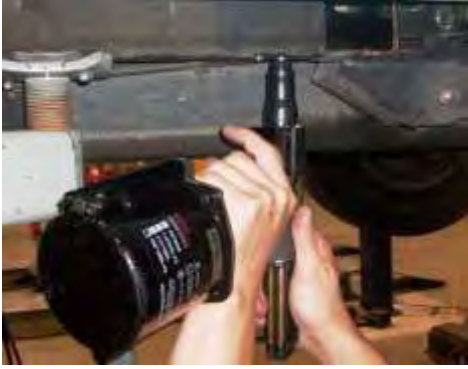
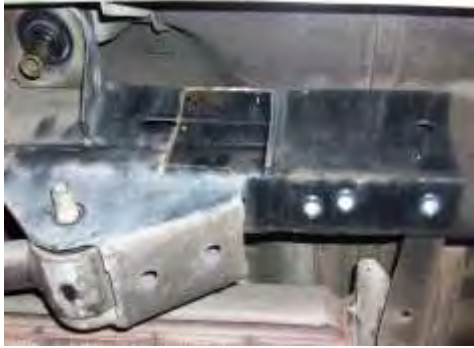
Figure 22 Pop-nut Installer ready for use.	Figure 23 Passenger side Pop-nuts installed.

- b. When Installing Pop-nuts on the vehicle, be sure they are completely seated against the frame before pulling the trigger. See Figure 22.
 - c. After pulling trigger, continue to hold it down until the mandrel reverses direction. Once reversed pull back slightly and the mandrel will unthread from the Pop-nut. See Pop-nut Installer manual for details.

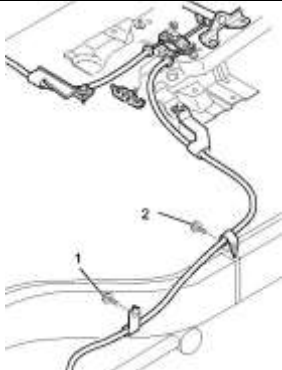
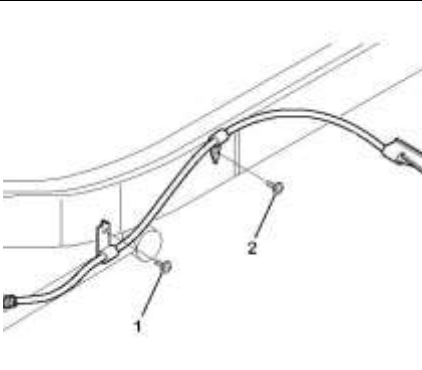
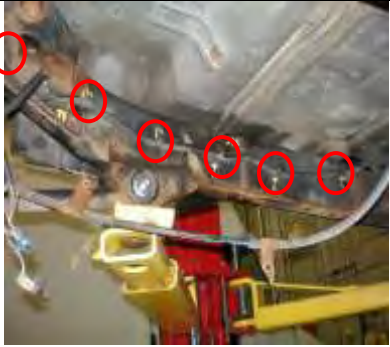
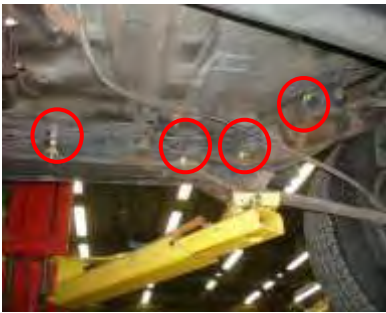
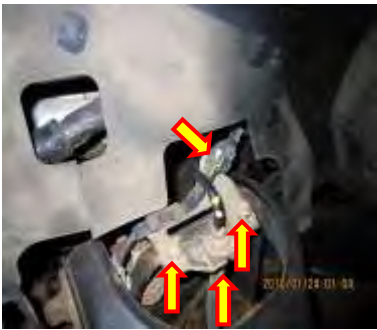
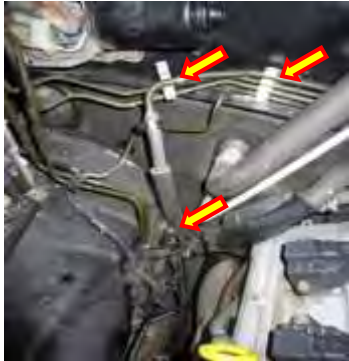
<p>Figure 31 Parking brake cable Pass.</p>	<p>Figure 32 Parking brake cable Dr.</p>	<p>Figure 33 Wire Harness</p>

<p>Figure 34 Brake Piping</p>	<p>Figure 35 ABS harness and pipe</p>	<p>Figure 36 Canister Pipe</p>

4. Remove/disconnect the following components per the service manual:
 - a. Parking brake cable passenger side mounting bolts (2 points). See Figure 31.

- b. Parking brake cable driver side mounting bolts (2 points). See Figure 32.
 - c. Wiring harness clips from frame driver side (6 points). See Figure 33.

- d. Brake piping clips passenger side clips (4 clips). See Figure 34.
 - e. ABS speed sensor harness driver and passenger side (4 points). See Figure 35

- f. Brake pipe retaining clip driver and passenger side (2 points). See Figure 35.
 - g. Canister pipe (3 points). See Figure 36.
 - h. Active suspension connector front R and L (if equipped).

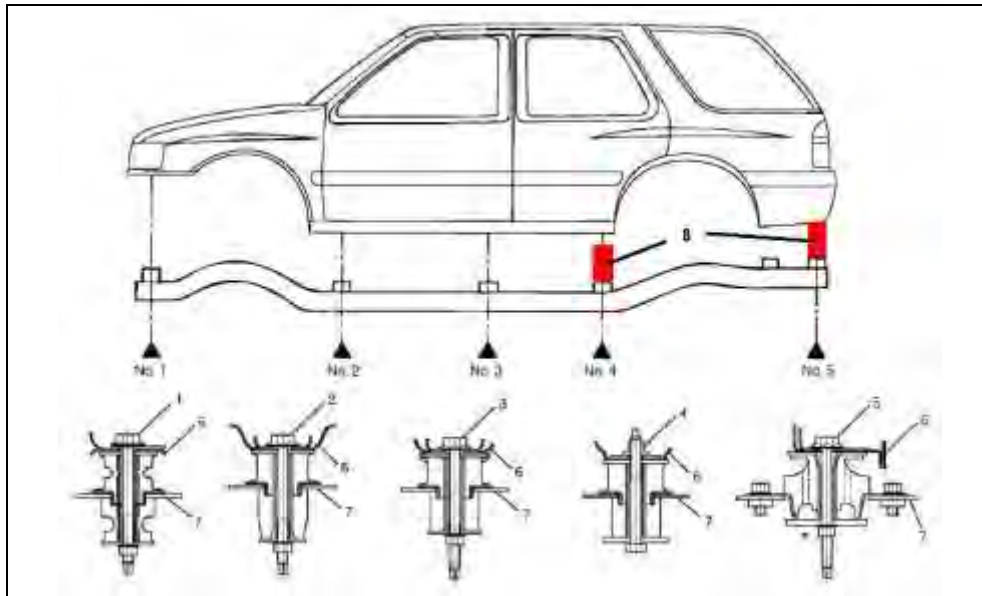
Figure 37
 1 – 5. Body Mounts
 6. Body Side Mounting Bracket
 7. Frame Side Mounting Bracket
 8. Wooden block support locations (body mount#5 and #4 right and left sides)

5. Remove body mount mounting nuts and bolt (mounts #1, #2, #4 and #5 use nuts/ mount #3 uses a bolt) for body mounts #1 through #5. See Figure 37.

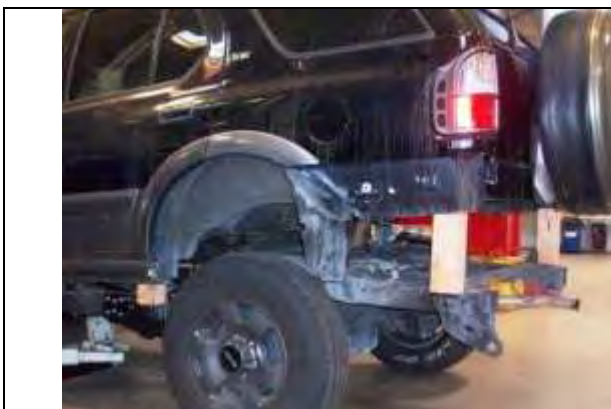
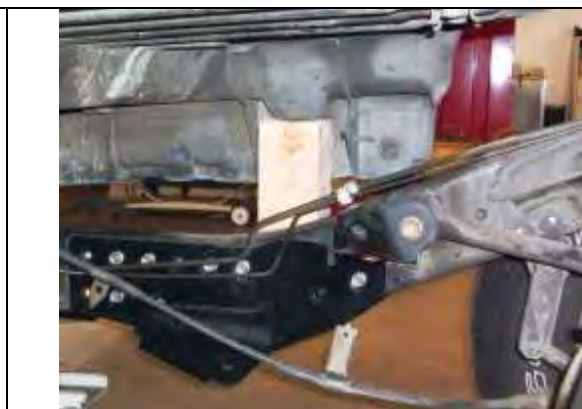
Figure 38
 Wood block installed at #5 body mount

Figure 39
 Wood block installed at #4 body mount

10. Using wooden blocks, support the body off of the frame at body mount #5 and #4. Body mount #5 should be 10.25 inches (260 mm) above the frame and body mount #4 should be at least 6.9 inches (175 mm) to allow access for the following steps. See Figures 38 and 39.

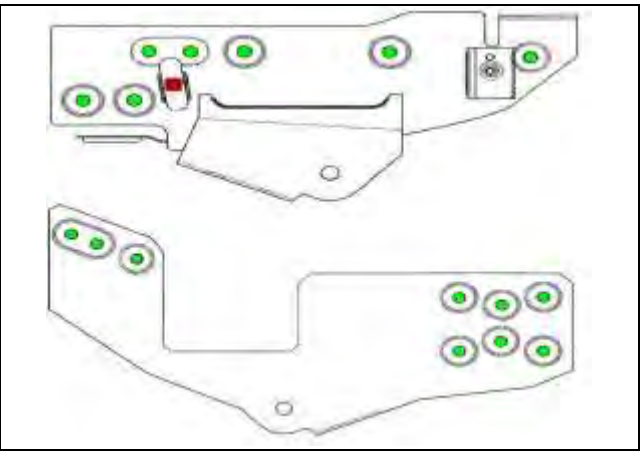
Figure 45
16 Green dots for Pop-nut locations
Red square is required clearance

18. Using the $\frac{1}{4}$ " drill bit guide or equivalent, drill $\frac{1}{4}$ " pilot holes for each bracket mounting point into the frame rail, 16 holes for each bracket. See Figure 45.

19. Using a $\frac{1}{4}$ " drill bit, drill a hole in the frame through the passenger side Type "B" bracket brake clip mounting hole. See Figure 45.

21. Locate the $\frac{1}{4}$ " hole drilled in step 17. Use the $\frac{33}{64}$ " drill bit and final drill this location. Mark this location with tape or chalk. This hole is required to provide clearance for the passenger side brake pipe clip. See Figure 45.
