Campaign Service

BULLETIN NUMBER:
SB10-11-S002A

Regional Safety Recall 10V-436

Corrosion Affecting the Forward Rear Suspension Lower Link Brackets

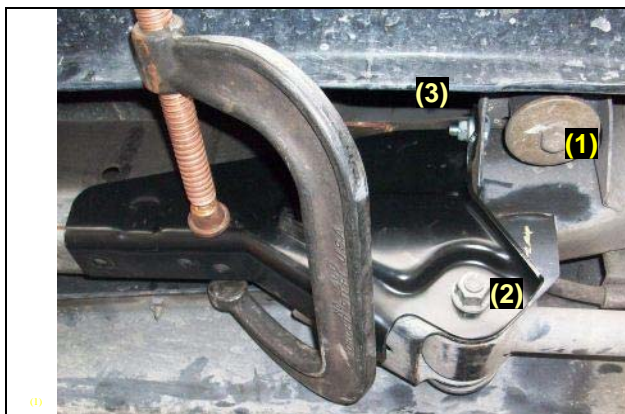
Figure 15: Driver side temporary installation (1998-

2000 models) <ol style="list-style-type: none"> 1. # 4 body mount. 2. Trailing link mounting nut. 3. Stud and nut 	– 2002MY only <ol style="list-style-type: none"> 1. # 4 body mount lower half removed. 2. Weld nut already in frame for some 2000MY vehicles and all 2001 through 2002MY vehicles 3. Stud and nut
--	--

4. Using a hammer, knock on the outside of the frame rail to loosen any rust on the inside of the frame.
5. Using a wire brush and scraper remove any loose coating material, welding splatter and rust from the outside frame and rear lower trailing link front mounting bracket area on both driver and passenger sides.
6. Temporarily install both Type “A” reinforcement brackets using the original lower link mounting nut, “C” clamp and new stud and nut. See Figures 15 and 16

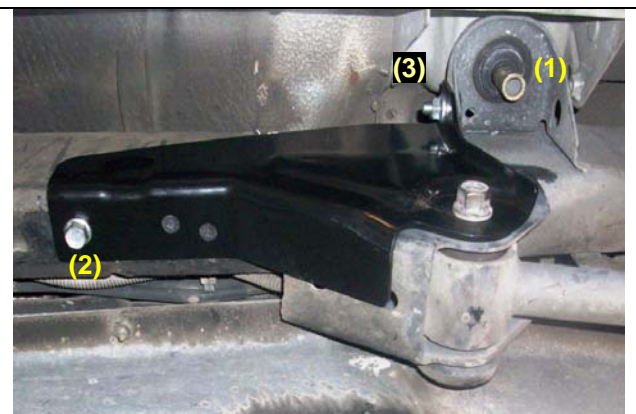
Figure 16: Driver side temporary installation (2000

NOTE: Some 2000MY vehicles' frames already have a nut welded into the driver side frame at location 2 in Figures 16 and Figure 17. For 2001 and 2002MY vehicles this location is for the fuel tank protector. DO NOT DRILL THIS LOCATION IF A WELDED NUT IS PRESENT

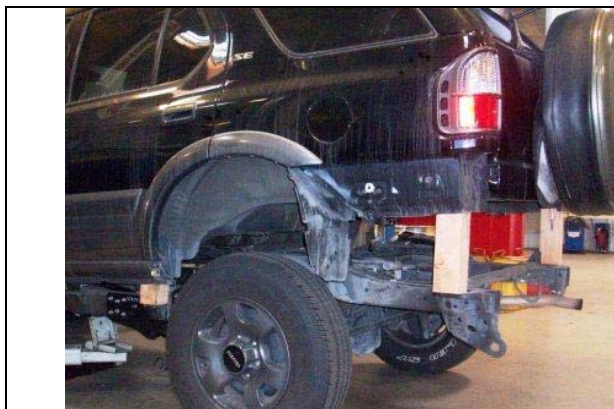
Figure 38
 Wood block installed at #5 body mount

CAUTION: Failure to install the wooden blocks as directed below can create a dangerous situation in which the rear section of the frame rail may break off, collapse to the ground and cause serious personal injury to the technician during the repair as well as permanent frame damage, making the vehicle unrepairable.

10. Using wooden blocks, support the body off of the frame at body mount #5 and #4. Body mount #5 should be 10.25 inches (260 mm) above the frame and body mount #4 should be at least 6.9 inches (175 mm) to allow access for the following steps. See Figures 38 and 39.
