TSB	Model	Sonata(YF)(2011)
	Group	Steering System(61)
	TSB No.	HRE10-61-P120-YF
Subject STEERING COLUMN INTERMEDIATE SHAFT CONNECTIONS INSPECTION	Published	10/7/2010
	Area & Distributor	GUAM (A31AA), PUERTO RICO (B35AA), PUERTO RICO (B35AB), PUERTO RICO (B35AC)

1. Description

This bulletin provides the procedure for inspecting to ensure that the steering column and the upper intermediate shaft universal joint (U joint), and the steering pinion splined shaft and the lower intermediate shaft U joint are properly connected and that both attaching bolts are tightened to the specified torque. Additionally, a procedure is provided to update the MDPS software.

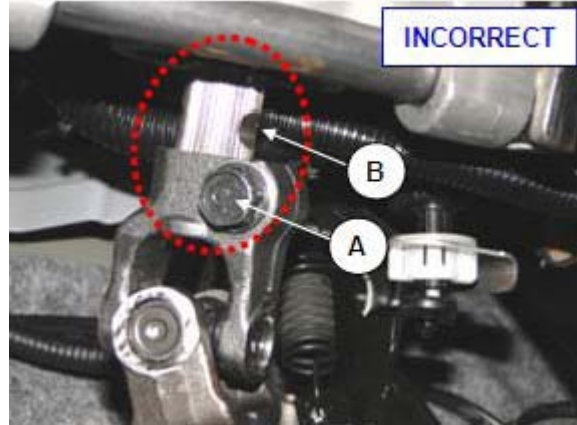
NOTE: The steering column-to-U joint bolt (A) must be fastened through the groove (B) in the end of the steering column.

4. Remove the steering column-to-U joint bolt.

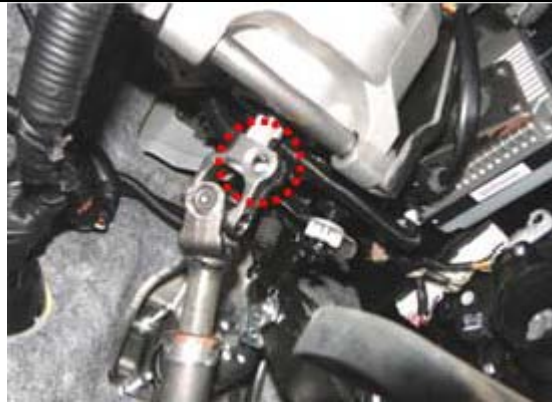
5. Inspect the bolt for damage/stripping/cross-threading. Inspect the corresponding threads in the U-joint. Replace both if damage is found.

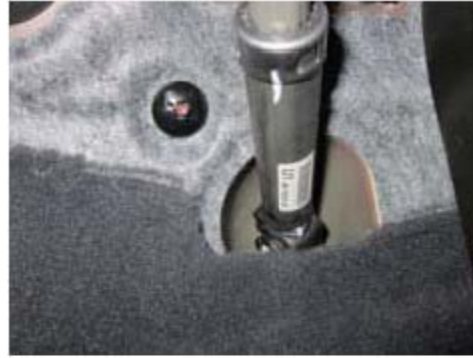
1. Pull back carpet to access lower end of steering intermediate shaft.
2. Inspect all 4 U-joint bearing caps. Turn the steering wheel to visually access them. Ensure they are properly fixed in the yoke by the four indentations. If the caps are loose, replace the steering intermediate shaft assembly.

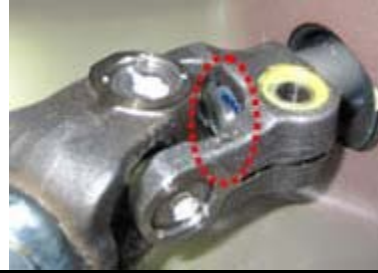
6. Inspect the bolt for damage/stripping/cross-threading. Inspect the corresponding threads in the U-joint. Replace both if damage is found.
