SERVICE BULLETIN NO. SB-08-131

**SUBJECT: ArvinMeritor – Technical Bulletin – Safety Recall:
Lower Axle Seat Weld Inspection and Repair for Meritor RideSentry™**

Lower Axle Seat Weld Inspection and Repair for Meritor RideSentry™ MPA Series Sliding Tandem Trailer Air Suspension Systems

TP-10172
Issued 09-10
(16579)

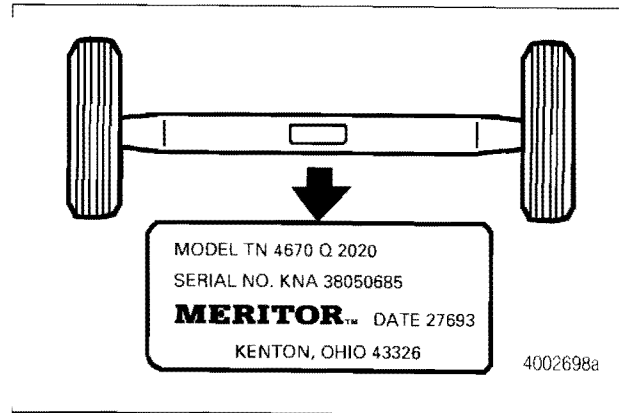
Figure 3

- Complete 17-digit vehicle identification number (VIN)
- ArvinMeritor axle model and serial number. Figure 3.
- Vehicle owner's name, address and telephone number
- Vehicle in-service date
- Repair facility's name, address and telephone number
- Repair facility's hourly rate
