Recall Bulletin

PRODUCT SAFETY RECALL

SUBJECT: Power Steering Line Contact

MODELS: 2010-2011 Buick Lucerne Equipped with V8 Engine
2010-2011 Cadillac DTS

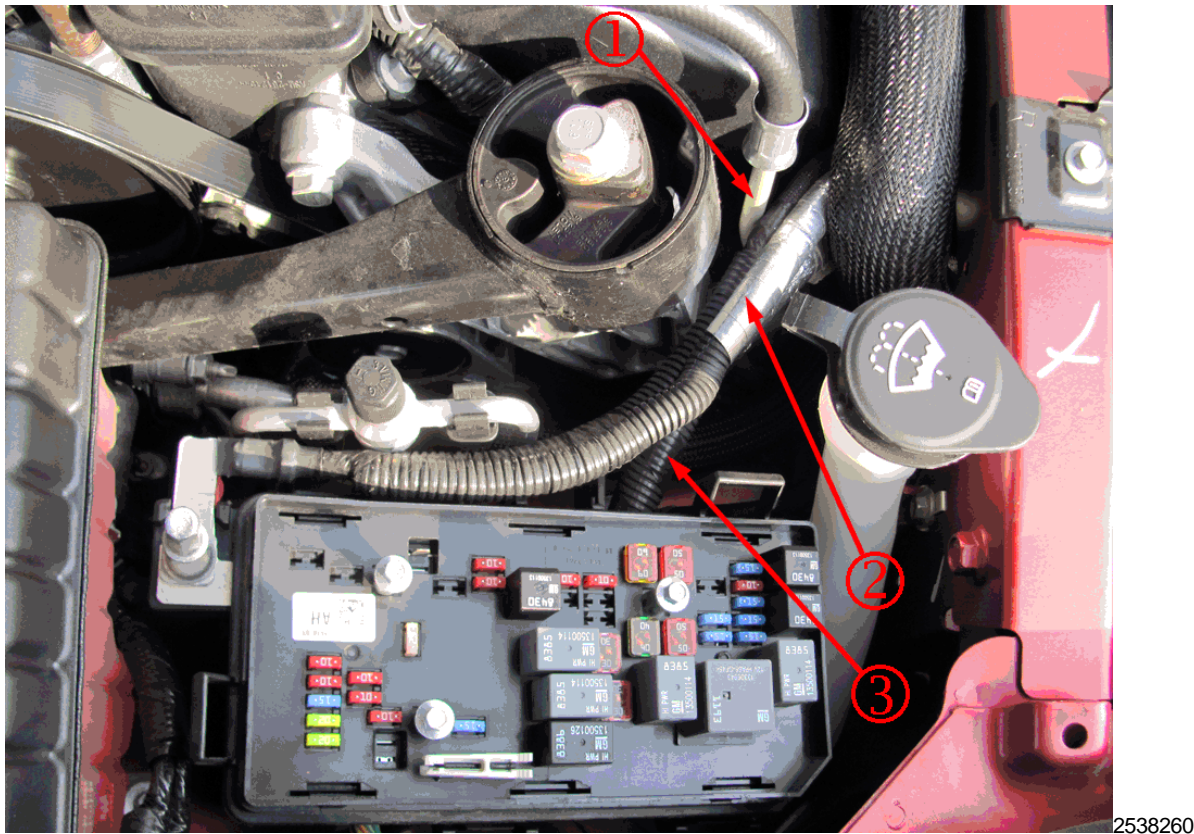
5. Examine the starter/alternator cables (2) and engine wire harness (3) at the power steering line and power steering bracket (1) location.
- If the cables are twisted or touching the power steering line or power steering line bracket, proceed to Step 6.
 - If the starter/alternator cables and engine wire harness are NOT twisted or touching the power steering line or power steering line bracket, proceed to Step 13.

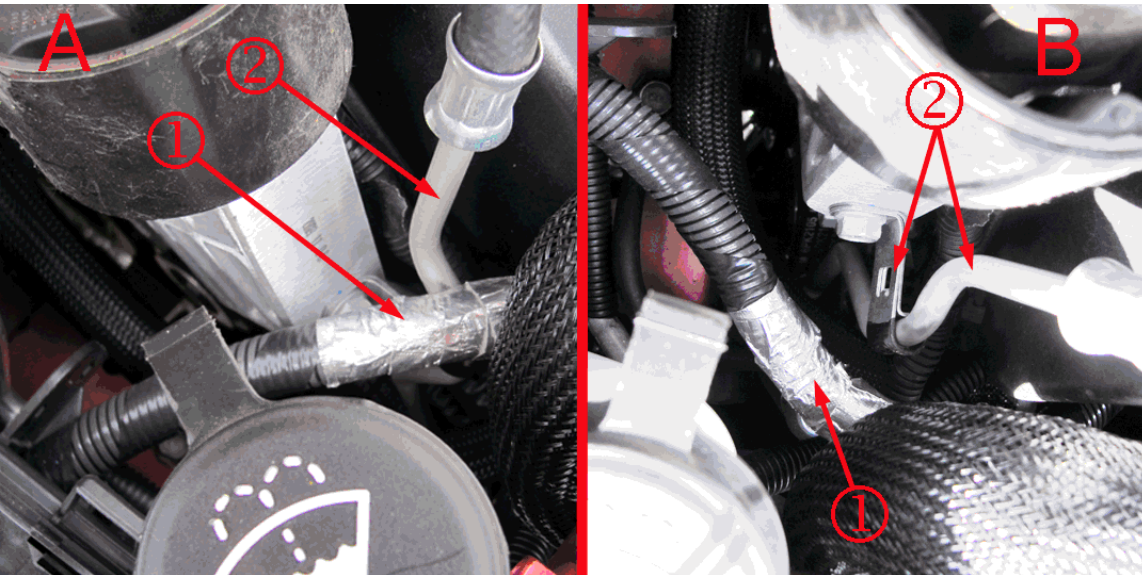
2538258

Note: The (A) portion of the illustration shows the line touching the power steering line. The (B) portion of the illustration shows the engine wire harness tucked below and away from the power steering line and power steering line bracket.

8. Push the engine wire harness (1) below and away from the power steering line and power steering line bracket (2).

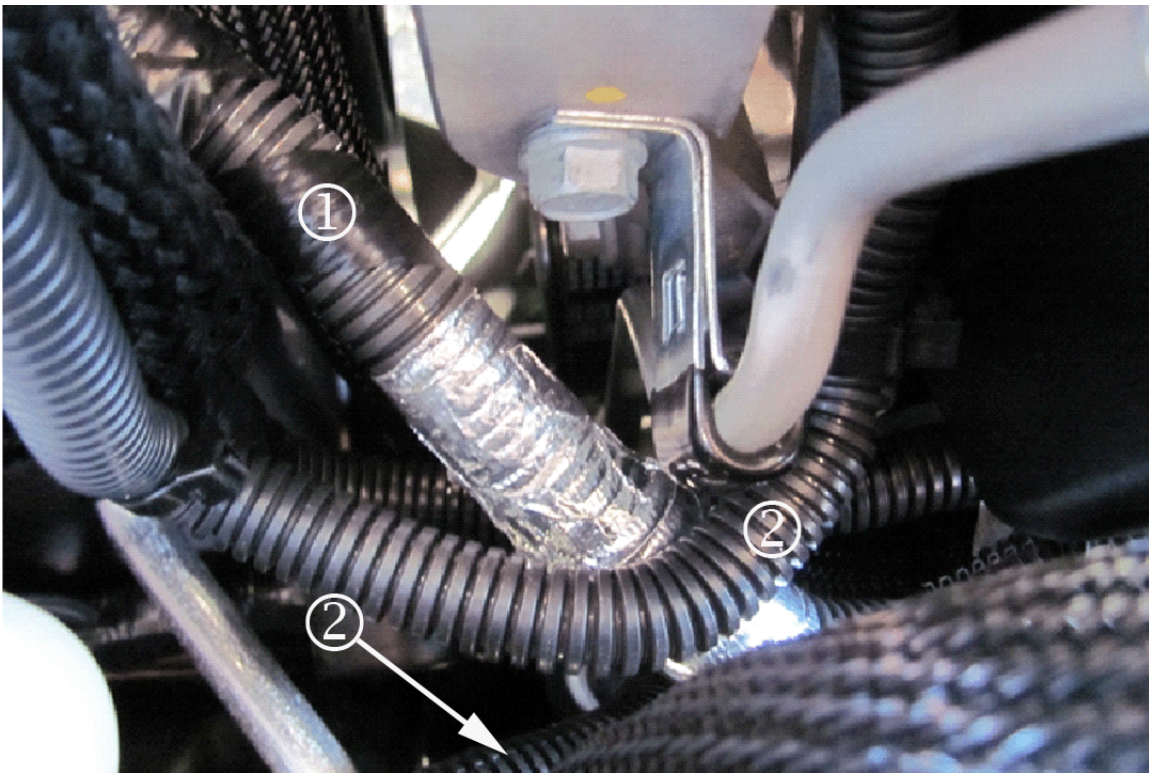
2540623

8. Determine if the engine wire harness (1) has been routed between the starter and alternator cables (2).
 - If the engine wire harness (1) is routed between the starter and alternator cables (2), proceed to Step 9.
 - If the engine wire harness (1) is NOT routed between the starter and alternator cables (2), proceed to Step 10.
