Technical Bulletin

Lower Axle Seat Weld Inspection and Repair for Meritor RideSentry™ MPA Series Sliding Tandem Trailer Air Suspension Systems

TP-10172
Issued 09-10
(16579)

NOTICE: Defect Information Notice – Certain ArvinMeritor MPA trailer suspension systems manufactured and shipped by ArvinMeritor Inc.

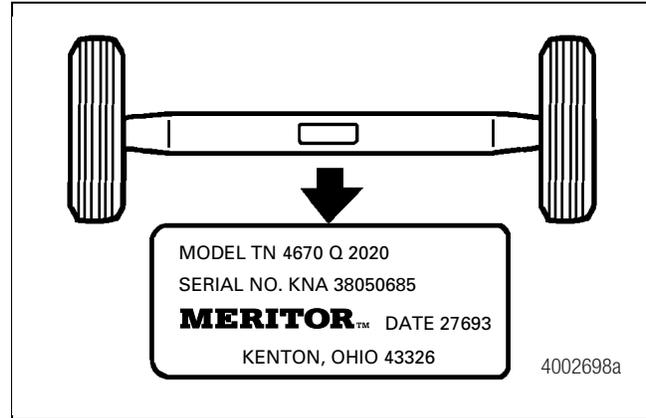
Figure 3

- Complete 17-digit vehicle identification number (VIN)
- ArvinMeritor axle model and serial number. Figure 3.
- Vehicle owner's name, address and telephone number
- Vehicle in-service date
- Repair facility's name, address and telephone number
- Repair facility's hourly rate
