SUBJECT: RECALL R10RW POWER CABLE LUG ORIENTATION

R10RW

Incorrect Power Cable Lug Orientation

Models Affected: 2004 through 2009 Vision

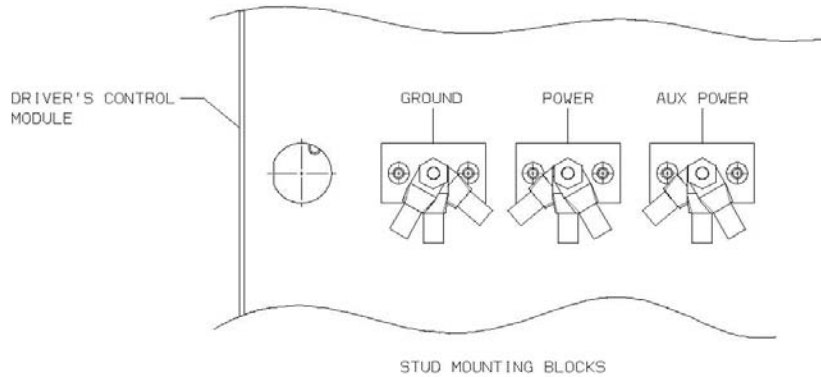
Incorrect Power Cable Lug Orientation

4. Inspect the electrical cable connections at the Power Stud and Aux Power Stud, if installed. See the diagram below to determine if the cables were installed correctly. ALL terminal lugs on each power stud should be oriented such that the barrel of the lug is further away from the mounting surface of the isolated stud. The flat side of terminal end (lug) must be down.

5. If the cables were installed incorrectly, remove the nut securing the cables. Then remove the cables and reinstall correctly per the diagram above. Make sure the terminal lugs are fanned out on the stud as opposed to directly on top of each other. Vice-grip pliers are recommended when turning incorrectly installed cable terminal lug to the correct orientation of flat side down.
