**SUBJECT:   RECALL R10SB TRW INTERMEDIATE STEERING SHAFT WELD**

### Service Procedure # COL-201

#### IGEN 3 Intermediate Shaft Weld Location Inspection Procedure

## TRW IGEN3 Intermediate Steering Shaft Assembly

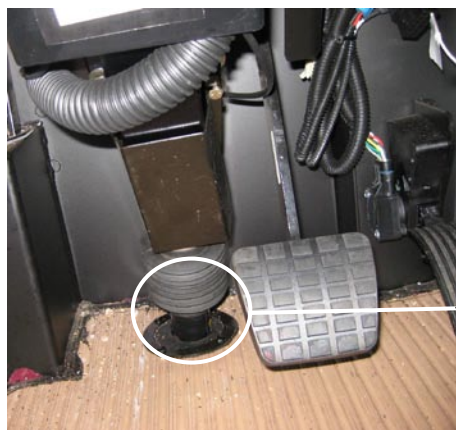
5. The upper shaft TRW date code identification stamped on the shaft is located above the floor in the driver's area. Turn the steering wheel to rotate shaft for stamped number to be visible.
