BLUE BIRD

SUBJECT: RECALL R10SB TRW INTERMEDIATE STEERING SHAFT WELD

Recall R10SB TRW Intermediate Steering Shaft Assembly Inspection Reply Sheet

IGEN 3 Intermediate Shaft Weld Location Inspection Procedure

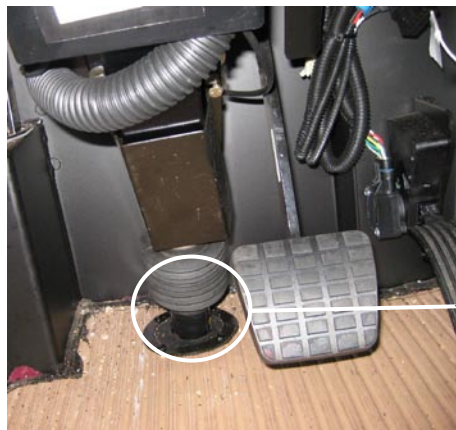
5. The upper shaft TRW date code identification stamped on the shaft is located above the floor in the driver's area. Turn the steering wheel to rotate shaft for stamped number to be visible.

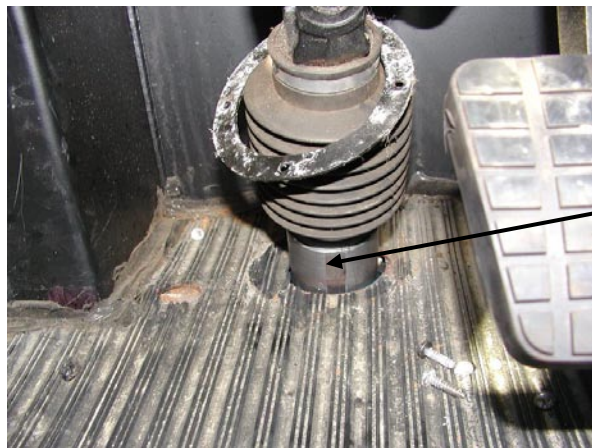
TRW Inspection Tool

10. The window for the inspection will be visible from underneath driver's floor. Rotate the shaft by turning the steering wheel to inspect weld per TRW Service Procedure # COL-201. If the part passes, follow TRW Service Procedure # COL-201 and then mark the Blue Bird Sheet. If the part fails, mark the sheet and return to the Blue Bird Recall Administrator. **NOTE:** If the weld cannot be seen in the installed position, remove the shaft for inspection. New fasteners **MUST** be use to reinstall the shaft.

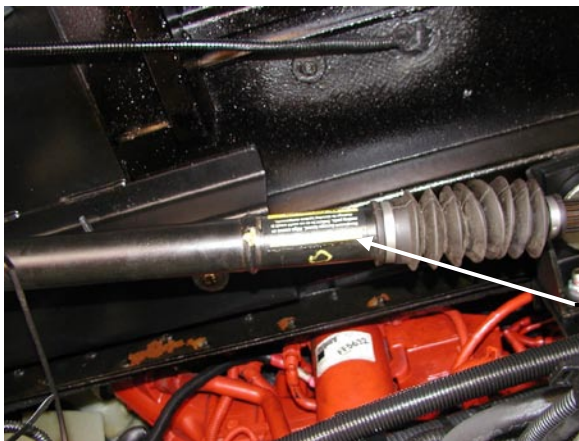
Date Code Location

5. The lower shaft TRW date code identification stamped on the shaft is located on steering gear end of the shaft. Turn the steering wheel to rotate shaft for stamped number to be visible.
