**BLUE BIRD**

**SUBJECT: RECALL R10SL STARTER CABLE AND ENGINE WIRING  
HARNES MAY CONTACT FAN HUB**

# Starter Cable and Wiring Harness May Contact Engine Fan Hub

**Models Affected:** 2007 – 2011 All American (A3FE) and Commercial Series (C3FE), and 2010-2011 All American (D3FE) equipped with Cummins ISB Engines

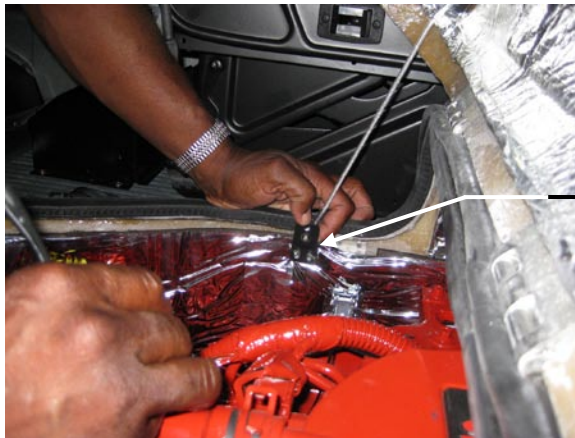
Remove machine screw and locknut
