Subject: Safety Recall B0A (interim B1A) – **Interim Notification**
Certain 2004 – 2006 model year Highlander/Highlander HV
Driver's Side Floor Carpet Cover and Retention Clips

Safety Recall B0A (INTERIM B1A) – INTERIM Carpet Floor Cover and Retention Clip Inspection 2004 through Certain Early 2006 MODEL YEAR Highlander/Highlander HV

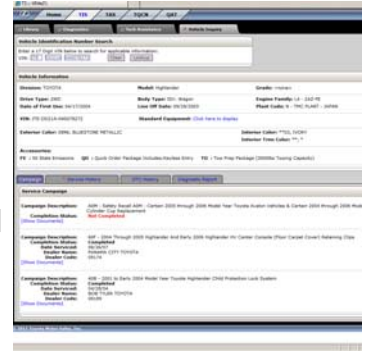
2. Inspect Floor Carpet Cover to ensure all clips are present and secure.

NG

B. If **In-Complete** proceed with performing 60F, once completed no further action required for INTERIM Inspection.
