TOYOTA CUSTOMER SERVICES

Volume: XVIII
Number: TC11-016
Date: 4/27/2011
 Action
 Retain
 Information

Subject: Safety Recall B0A – *Remedy Parts Available*
Certain 2004 – 2006 model year Highlander/Highlander HV
Driver's Side Floor Carpet Cover and Retention Clips

TECHNICAL INSTRUCTIONS

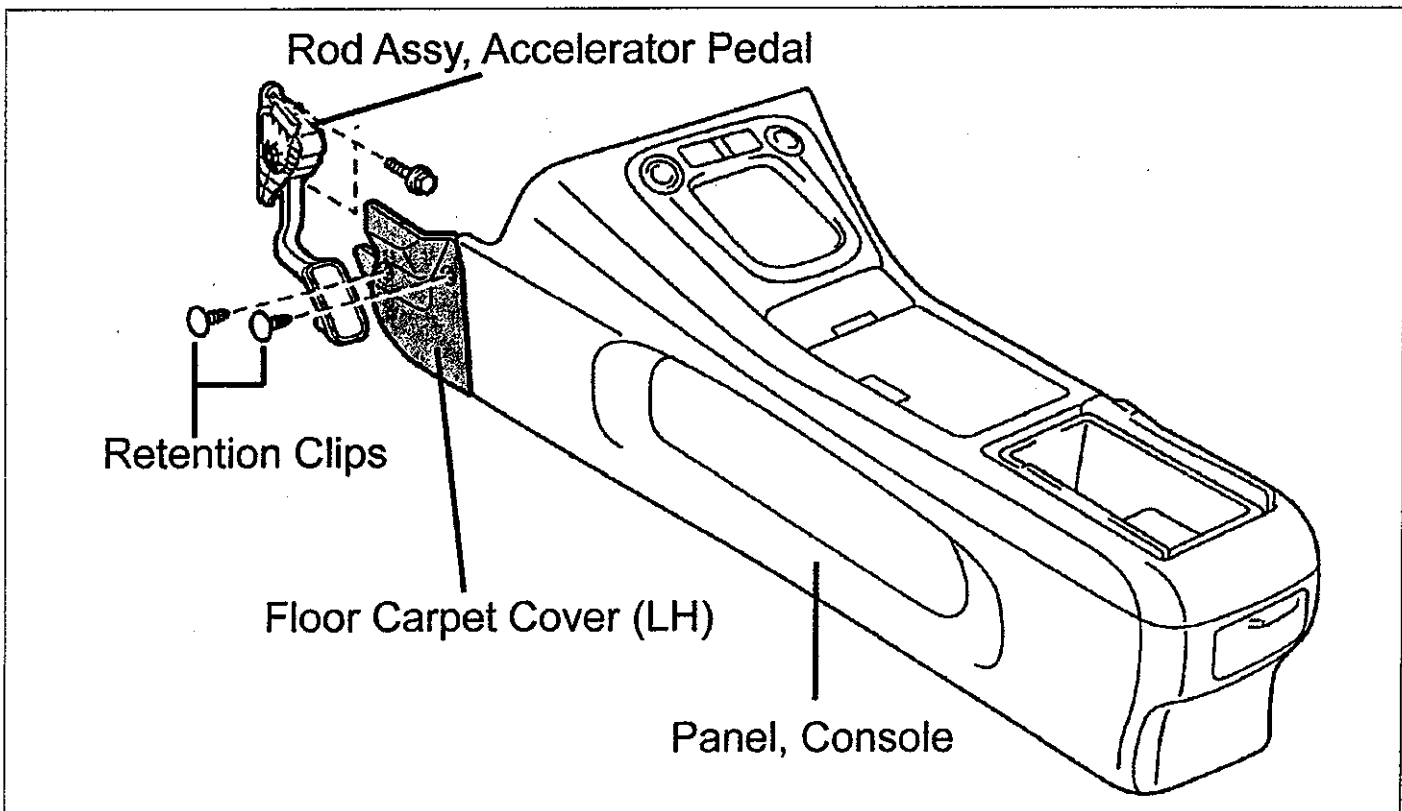
V. WORK PROCEDURE

In certain 2004 through 2006 model year Highlander and Highlander HV vehicles, if the forward retention clip used to secure the driver's side Floor Carpet Cover, which is located in front of the center console, is not installed properly, the cover may lean toward the accelerator pedal and interfere with the accelerator pedal arm. If this occurs, the accelerator pedal may temporarily become stuck in a partially depressed position rather than return to the idle position. An accelerator pedal temporarily stuck in a partially depressed position may increase the risk of a crash.

A. REPLACE THE CARPET COVER AND CLIPS
