# TOYOTA

Subject: Safety Recall B0A – **Remedy Parts Available**  
Certain 2004 – 2006 model year Highlander/Highlander HV  
Driver's Side Floor Carpet Cover and Retention Clips

**TECHNICAL INSTRUCTIONS**

**SAFETY RECALL B0A**

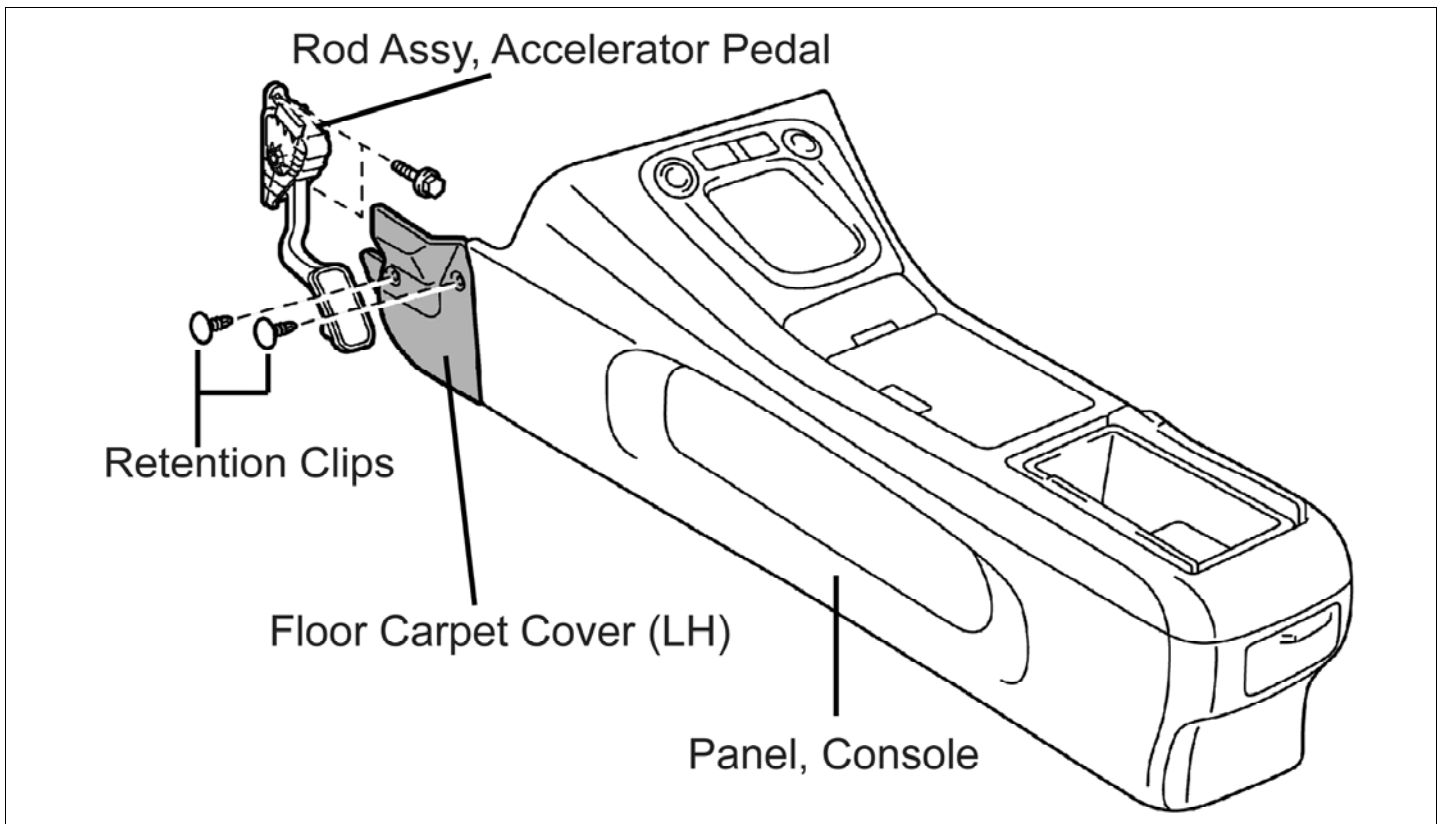
### V. WORK PROCEDURE

In certain 2004 through 2006 model year Highlander and Highlander HV vehicles, if the forward retention clip used to secure the driver's side Floor Carpet Cover, which is located in front of the center console, is not installed properly, the cover may lean toward the accelerator pedal and interfere with the accelerator pedal arm. If this occurs, the accelerator pedal may temporarily become stuck in a partially depressed position rather than return to the idle position. An accelerator pedal temporarily stuck in a partially depressed position may increase the risk of a crash.

## A. REPLACE THE CARPET COVER AND CLIPS

The accelerator pedal **MUST** be removed. The center console panel will be damaged if the pedal is not removed.
