DAIMLER

**Re: Defect Information Report – Supplemental Report No. 1
11V-249, FL-605
Gunite Automatic Slack Adjusters**

Subject: Gunite Automatic Slack Adjusters

June 2011
FL605A-Z
NHTSA #11V-249
Transport Canada #11-163

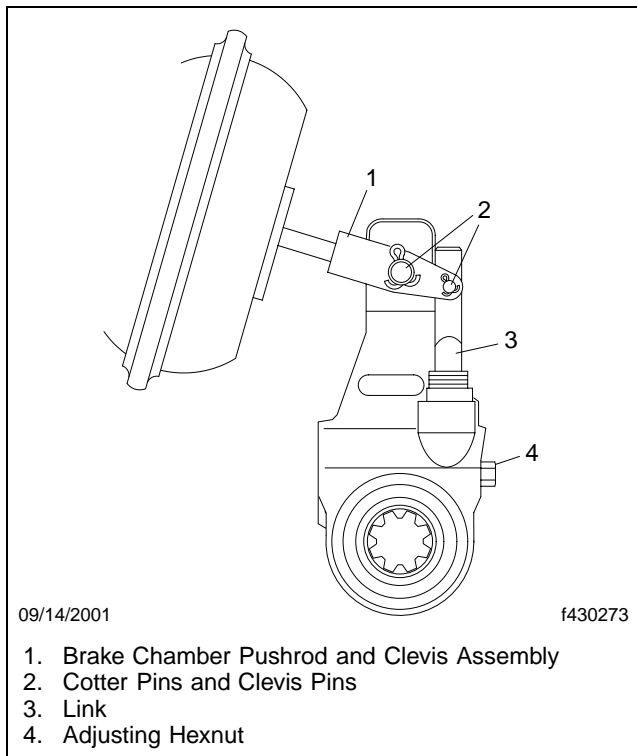
Fig. 2, Slack Adjuster (attached to welded clevis)

The factory installed brake chambers have welded clevises on the pushrod. See **Fig. 2**. On replacement brake chambers, the clevis is threaded onto the pushrod, and has a jam nut installed. See **Fig. 3**.

1. Coat the camshaft splines, and the splines of the slack adjuster gear with an anticorrosive grease.
2. Using the old snap ring, install the automatic slack adjuster on the brake camshaft.
3. Turn the adjusting hexnut clockwise to rotate the slack adjuster toward the brake chamber until the holes line up.
4. Install the clevis pins and cotter pins.
