Toyota Motor Sales, U.S.A., Inc.
19001 South Western Avenue
Torrance, CA 90501
(310) 468-4000

Subject: Safety Recall B0G – **Remedy Notice**
2001 to 2003 Model Year Prius Vehicles
Replacement of Electric Power Steering (EPS) Pinion Shaft Nuts

TECHNICAL INSTRUCTIONS
FOR
SAFETY RECALL B0G
EPS PINION SHAFT NUTS REPLACEMENT
2001 – 2003 MODEL YEAR PRIUS

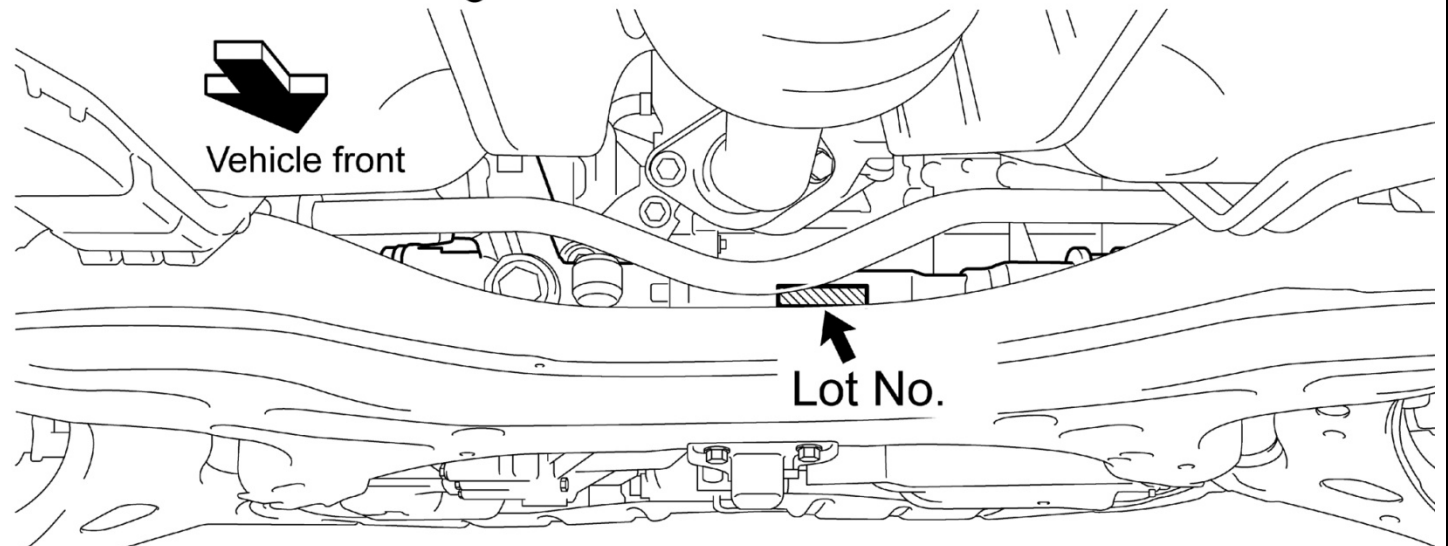
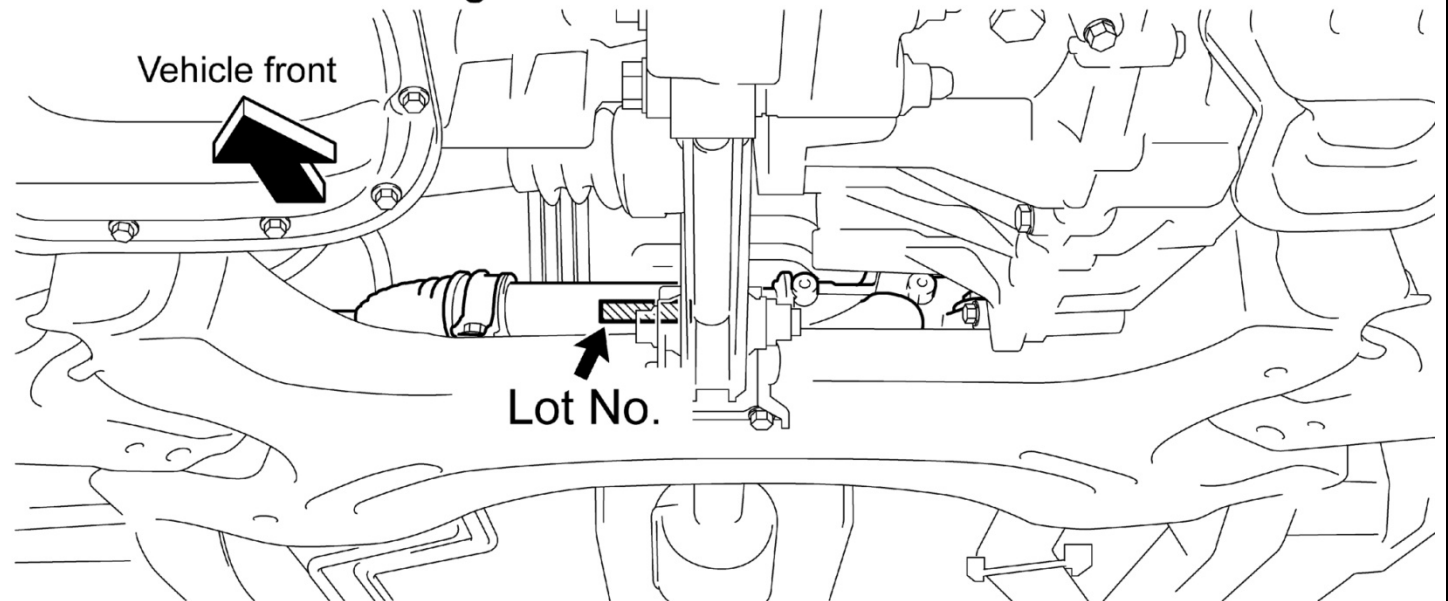
A. LOCATE AND INSPECT THE LOT NUMBER STICKER ON THE POWER STEERING GEAR

INSPECTION RESULT	ACTION REQUIRED
Below 138897 OR lot number cannot be determined	Proceed to SECTION VIII. POWER STEERING GEAR REMOVAL.
138897 or above	Record the lot number on the repair order. No further action is required. Campaign complete.

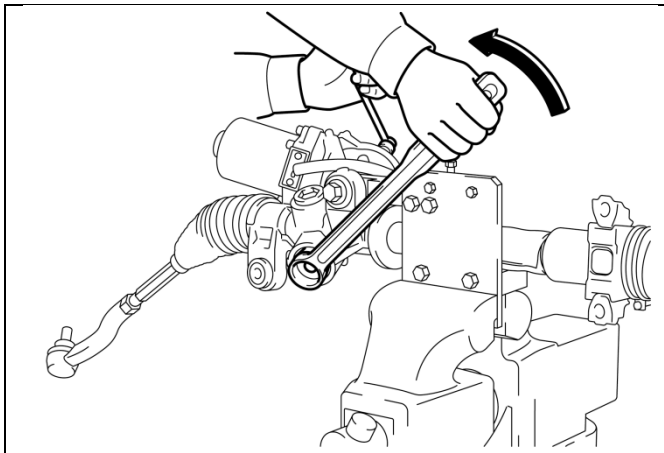
8. REMOVE THE PINION SHAFT LOCK NUT

NOTE: If the lock nut is loose before removal, there is **NO** problem with reusing the gear.

- a) Use a paper towel to clean the grease from around the nuts.
- b) Use the adjusting nut holding tool to hold the adjusting nut while removing the lock nut.

DO NOT use brake cleaner or an air gun at this time, contamination may occur.

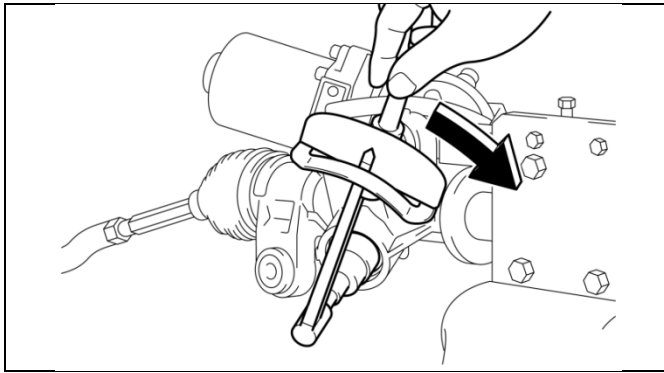
12. INSTALL THE PINION SHAFT ADJUSTING NUT

Pinion Shaft Nuts		Notes
Adjusting Nut	New	Thickness: 6.0mm Green chemical applied to nut (friction stabilizer)
	Old	Thickness: 7.5mm
Lock Nut	New	Thickness: 7.5mm Distorted thread locknut
	Old	Thickness: 7.5mm

NOTE: The green substance that is applied to the adjusting nut is a friction stabilizing coefficient agent. **DO NOT** remove it from the nut.

- Gently screw on the **NEW** adjusting nut while paying attention to the direction of installation.

- Confirm all grease is removed from the pinion shaft before installing the new nuts.
- If the pinion shaft threads are damaged and it is not possible to gently tighten the nut, the steering gear assembly **MUST** be replaced.

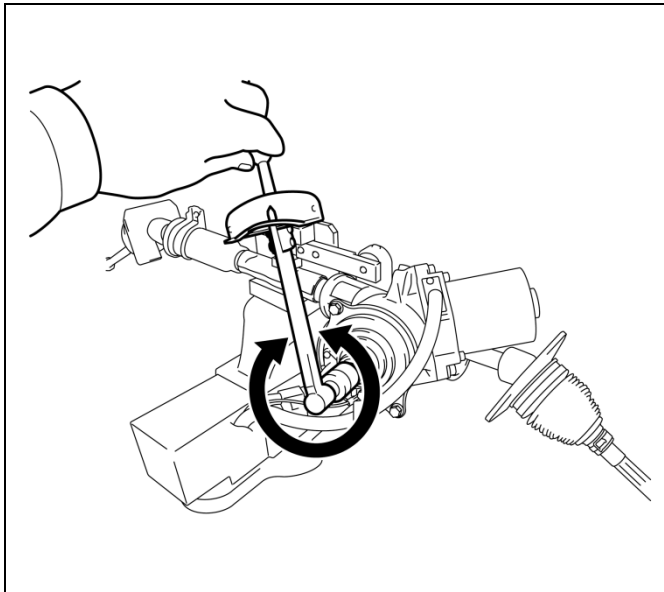
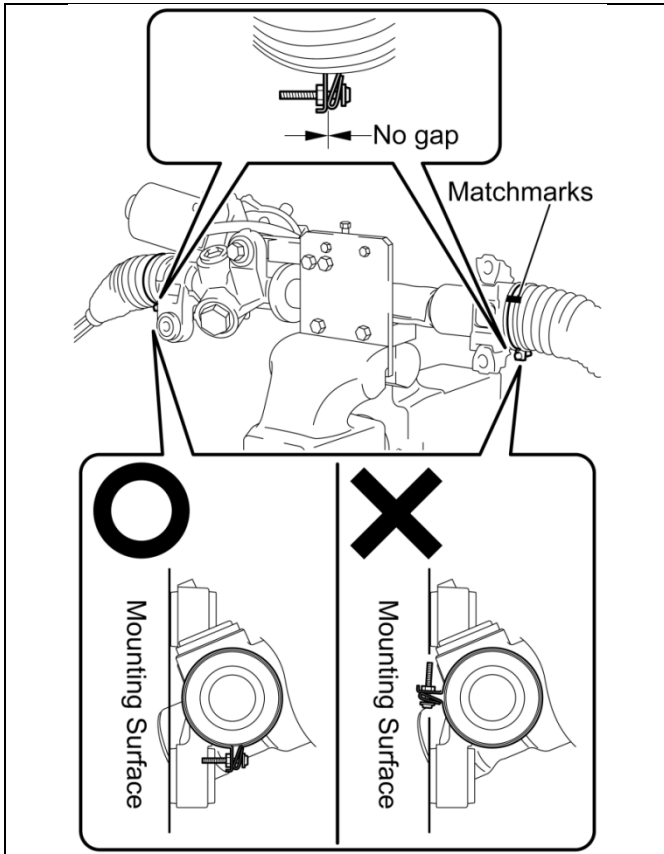
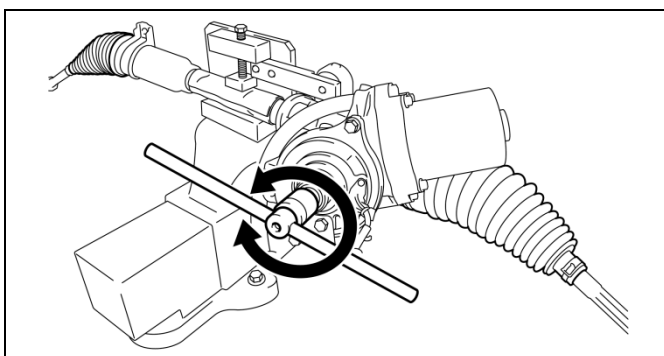
22. CHECK THE OVERALL PRELOAD

- If the rack boot stoppers are not installed, the preload measurement **WILL NOT** be accurate.
- Because the steering gear uses a variable gear ratio, preload **MUST** be measured with the steering gear in the straight ahead position.

Specification: 1.0 to 3.0 Nm (9-26.5in. lbf) within 1 rotation of straight ahead position

- c) Rotate the pinion shaft 1 complete rotation to the **right** using the torque wrench (00002-02955).
- d) Return the steering gear to the straight ahead position.
- e) Rotate the pinion shaft 1 complete rotation to the **left** using the torque wrench (00002-02955).

NOTE: If the preload is not within specifications, replace the steering gear assembly.

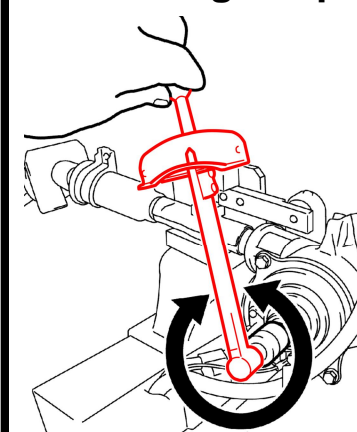
8. Checking the pinion shaft preload

SST: 0002-02955
Torque: 0-2.5 Nm
(0-22in. lbf)
Rotation Speed: Approx.
3 seconds per rotation

- Confirm the steering gear is in the straight ahead position.
- It is normal if the preload is different between right and left rotation.
- Keep rotation speed constant.

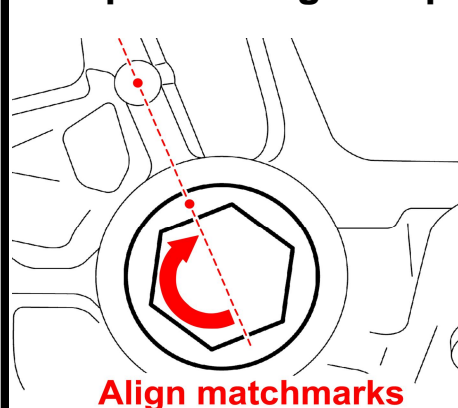
9. Repositioning the spring cap

Cap Protrusion: Approx. 7mm (1 rotation = ~1.5mm)

- Confirm the match marks align correctly after repositioning the cap.
- If the protrusion does not meet the spec., the cap may be out of position by 1 rotation.

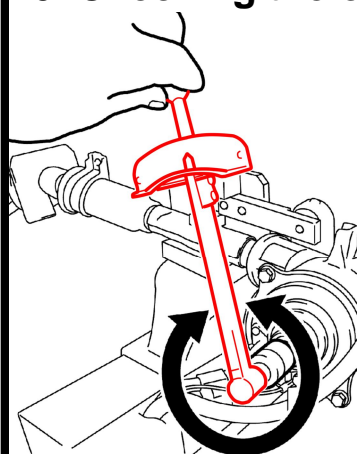
10. Checking the overall preload

Torque: 1-3.0 Nm
(9-26.5in. lbf)
Rotation Speed: Approx.
3 seconds per rotation

- Set the pinion shaft and confirm the steering gear is in the straight ahead position.
- It is normal if the preload is different between right and left rotation.
- Keep rotation speed constant.

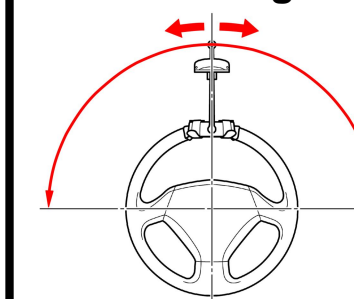
13. Confirming the steering torque

- **DO NOT** perform this inspection on alignment slip plates.
- If there is a noticeable difference in steering feel, the nuts may not have been set correctly.

- This information can be used when explaining the change in steering effort that may result from this work.
