December 19, 2011

Subject: Safety Recall BLD (Interim B2D) - **Remedy Available**
Certain 2006 - 2007 Model Year RX 400h Vehicles
Intelligent Power Module (IPM) Replacement

TECHNICAL INSTRUCTIONS
FOR
SAFETY RECALL BLD
INTELLIGENT POWER MODULE TRANSISTOR REPLACEMENT
CERTAIN 2006 – 2007 MODEL YEAR RX 400h

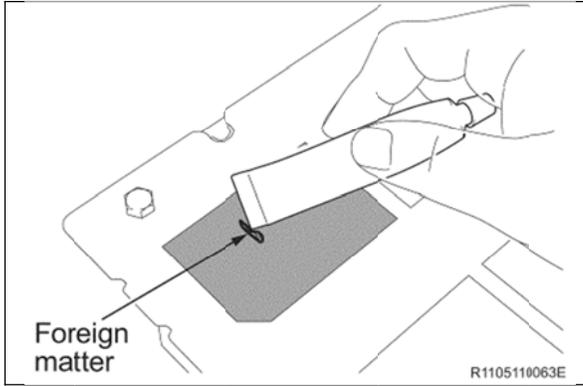
<p>CONDITION: Foreign material in the grease.</p> <p>ACTION: Proceed to: STEP C #1. REMOVE FOREIGN MATERIAL FROM THE GREASE</p>

1. REMOVE FOREIGN MATERIAL FROM THE GREASE

- a) Use one of the tubes of grease to remove the foreign material from the grease.

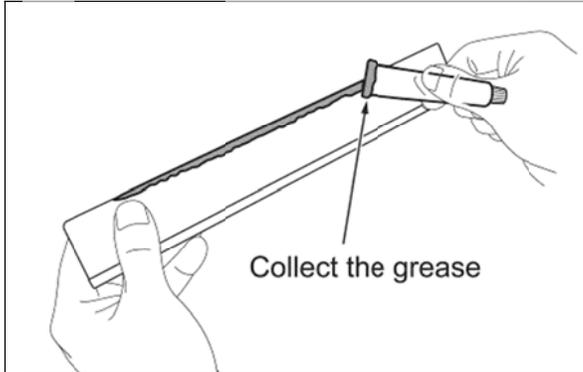
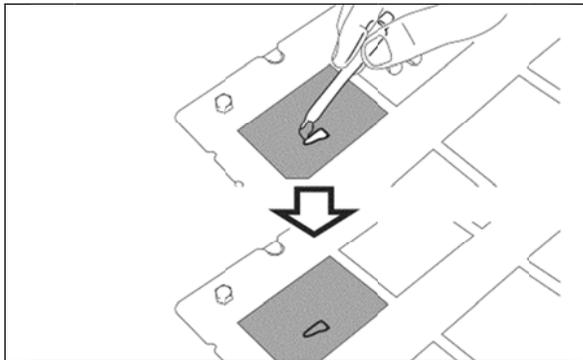
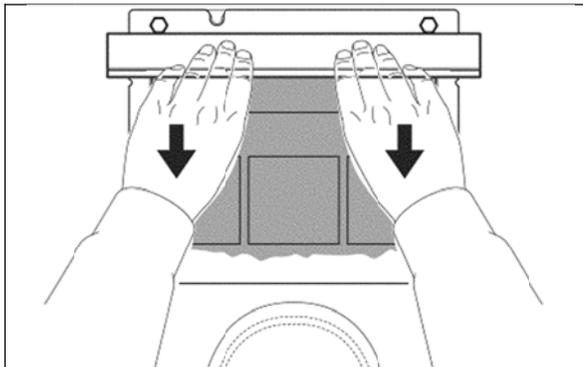
<p>CONDITION: Grease unsmooth. Metal surface of the IPM transistor visible through the grease.</p> <p>ACTION: Proceed to: STEP C #2. REAPPLY GREASE TO THE NEEDED AREAS</p>

<p>CONDITION: Hole or imperfection in the grease exposing the metal surface of the IPM transistor.</p> <p>ACTION: Proceed to: STEP C #2. REAPPLY GREASE TO THE NEEDED AREAS</p>

2. REAPPLY GREASE TO THE NEEDED AREAS

- a) Collect the grease remaining on the squeegee using one of the tubes of grease.

- b) Apply the grease the areas with a shortage.

- c) Use the squeegee as before to smooth the grease.

- d) Reconfirm the condition of the grease using the confirmation steps on the previous page.

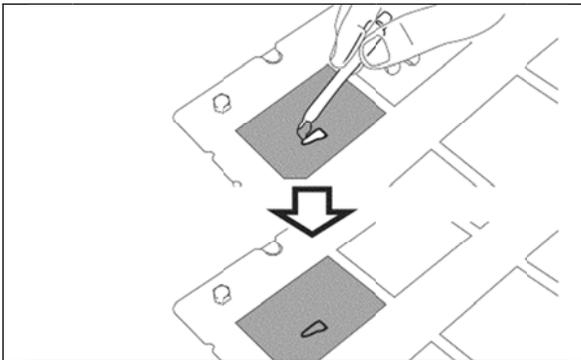
<p>CONDITION: Grease unsmooth. Metal surface of the IPM transistor visible through the grease.</p> <p>ACTION: Proceed to: STEP C #2. REAPPLY GREASE TO THE NEEDED AREAS</p>

<p>CONDITION: Hole or imperfection in the grease exposing the metal surface of the IPM transistor.</p> <p>ACTION: Proceed to: STEP C #2. REAPPLY GREASE TO THE NEEDED AREAS</p>

2. REAPPLY GREASE TO THE NEEDED AREAS

- a) Collect the grease remaining on the squeegee using one of the tubes of grease.

NOTE: Confirm the tube is clean before use.
