Altec Environmental
Products, LLC
Shelby, NC

MAB 547

MANDATORY ACTION BULLETIN

Axle Spindle Inspection and Replacement

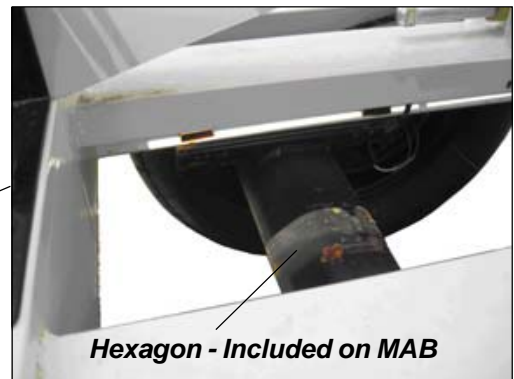
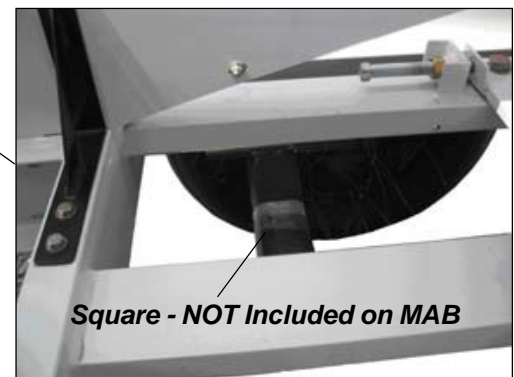
Figure 1 — WC126A/166A Axle Identification

The two different axles on WC126A/166A Chippers can be identified by their shape (refer to Figure 1). If the axle tube is approximately 3 inches wide and square in shape, the MAB does not apply and the chipper can be returned to service. If the axle tube is approximately 4^{5/8} inches wide and hexagonal in shape, the MAB applies to this unit and it **MUST** be inspected as described in this MAB.
