PRODUCT CAMPAIGN BULLETIN

APPLICABILITY: 2011 Subaru Legacy & Outback **NUMBER:** WWV-33
SUBJECT: Moonroof (Sunroof) Glass **DATE:** September 2011

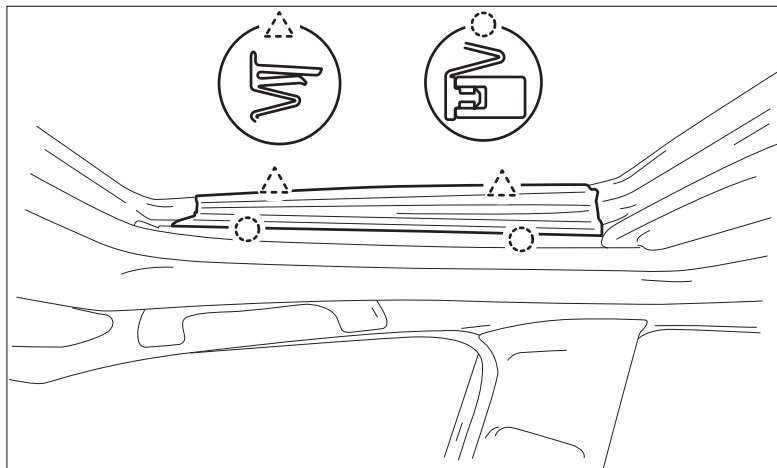
- a) Completely close the glass lid, and then open the sunshade.
- b) Disconnect the claws and then remove the lid cover.

CAUTION: When removing the clip, use great care not to damage the roof trim.

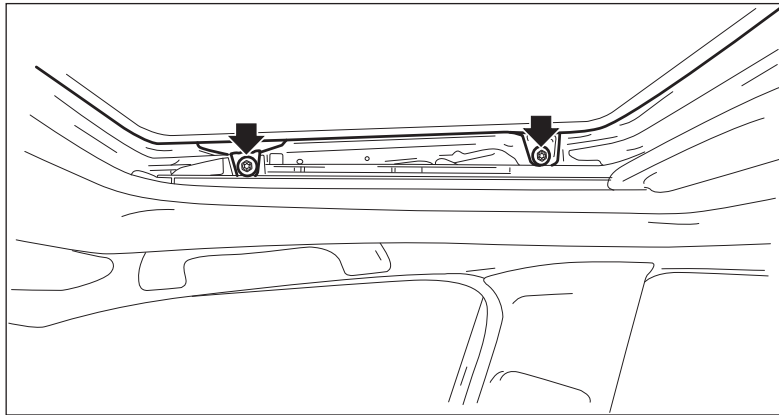
- c) Remove the bolts and then remove the moonroof glass.

CAUTION: Be careful not to damage or scratch the moonroof glass.

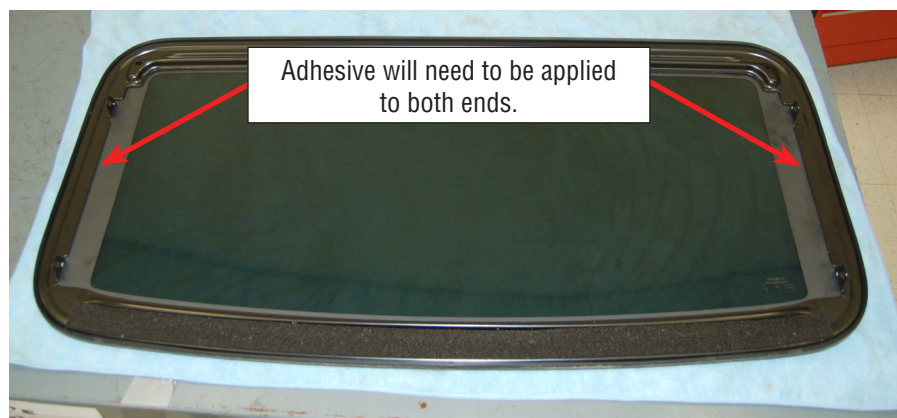
- 2) Place moonroof glass on a covered workbench frame side up.

- 3) **IMPORTANT:** To ensure proper adhesion, clean the appropriate areas of the glass and frame with a suitable cleaner such as household isopropyl alcohol.
- 4) Prepare the Adhesive Applicator.
