MAB 547

MANDATORY ACTION BULLETIN

Units Affected: DC912A Chippers (chassis s/n ending with 9S200342 through BS200265)
WC126A/166A Chippers (chassis s/n ending with AS200311 through BS200479)

Axle Spindle Inspection and Replacement

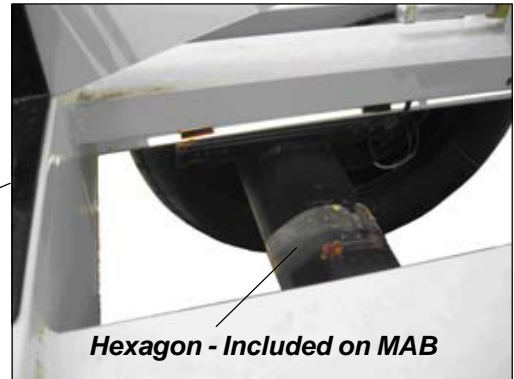
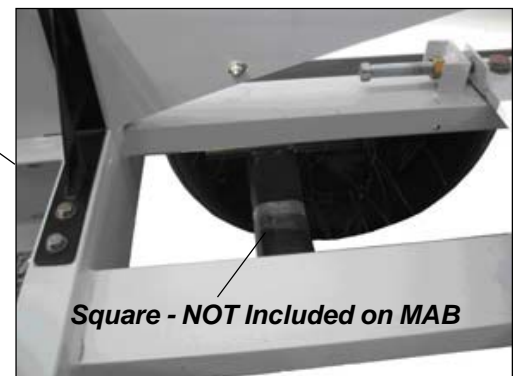
Figure 1 — WC126A/166A Axle Identification

The two different axles on WC126A/166A Chippers can be identified by their shape (refer to Figure 1). If the axle tube is approximately 3 inches wide and square in shape, the MAB does not apply and the chipper can be returned to service. If the axle tube is approximately 4⁵/₈ inches wide and hexagonal in shape, the MAB applies to this unit and it **MUST** be inspected as described in this MAB.
