SAFETY RECALL NOTICE

RE: New Safety Recall Notice- Arvin Meritor Recall Number 10E-057

Technical Bulletin

Procedures and Intervals to Inspect the Wheel Ends and Tighten the Spindle Nuts on Meritor TL Series Trailer Axles with Unitized Wheel Ends

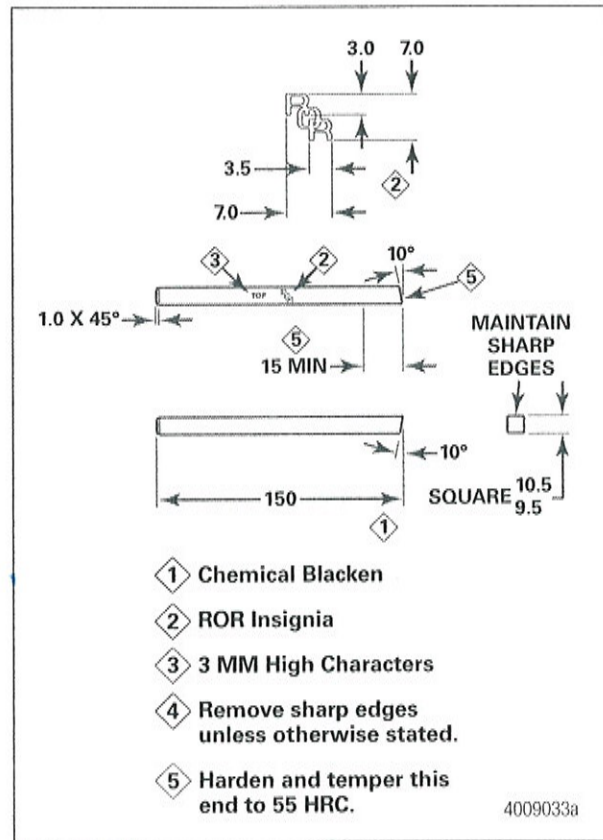
Figure 13

Staking Service Tool

9. Use a hammer and staking tool (Figure 13) to stake the stake washer to the spindle nut in **three** positions. Bend the washer to the stake profile as shown. Figure 3 and Figure 4.

9. Use a hammer and staking tool (Figure 13) to stake the stake washer to the spindle nut in **three** positions. Figure 10 and Figure 11.
