**SAFETY RECALL – ARVINMERITOR TL SERIES TRAILER AXLES**

NOTICE: Revised Defect Information Notice – concerning Spindle Nuts and Stake Washer on certain ArvinMeritor TL Series trailer axles.

## Procedures and Intervals to Inspect the Wheel Ends and Tighten the Spindle Nuts on Meritor TL Series Trailer Axles with Unitized Wheel Ends

TP-0860  
Revised 02-11  
(16579)

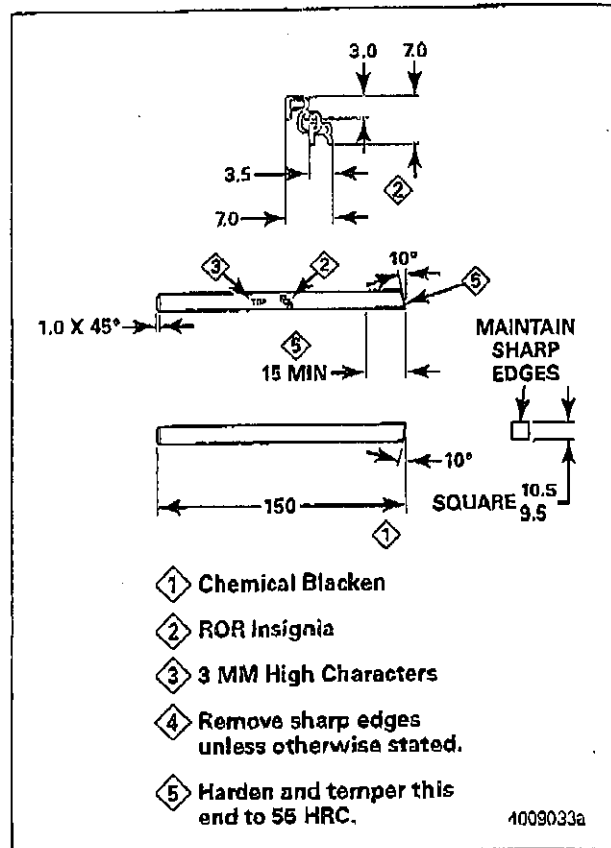
Figure 13

## Staking Service Tool

9. Use a hammer and staking tool (Figure 13) to stake the stake washer to the spindle nut in **three** positions. Bend the washer to the stake profile as shown. Figure 3 and Figure 4.

9. Use a hammer and staking tool (Figure 13) to stake the stake washer to the spindle nut in three positions. Figure 10 and Figure 11.
