Recall Bulletin

PRODUCT SAFETY RECALL

SUBJECT: Rear Axle Cross Pin Fracture

MODELS: 2011 Cadillac Escalade, Escalade ESV, Escalade EXT
2011 Chevrolet Avalanche, Colorado, Express, Silverado, Suburban, Tahoe
2011 GMC Canyon, Savana, Sierra, Yukon, Yukon XL

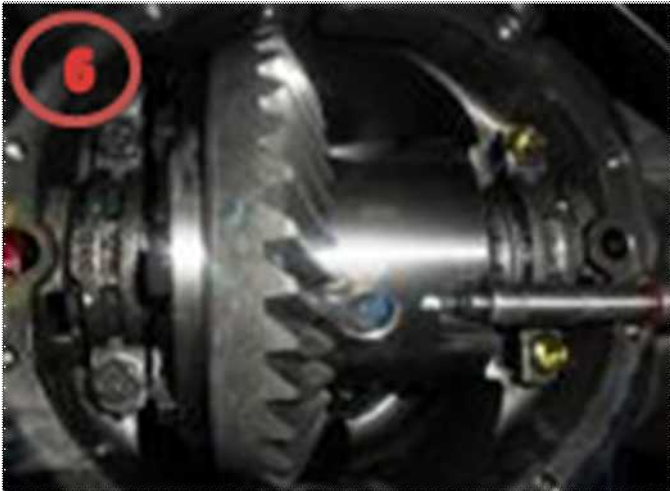
Note: If **BOTH** lines are not clearly visible on the cross pin, the cross pin **MUST** be replaced.

- If the head of the rear axle cross pin has orange and black paint marks or blue and black paint marks, do NOT replace the cross pin. Refer to illustration. Proceed to Step 14.
- If the head of the rear axle cross pin does NOT have a clearly visible orange and black paint mark, or a blue and black paint mark, (**BOTH** lines **MUST** be clearly visible), **REPLACE** the rear axle cross pin. Refer to illustration. Proceed to Step 10.
