Recall Bulletin

PRODUCT SAFETY RECALL

SUBJECT: Rear Axle Cross Pin Fracture

MODELS: 2011 Cadillac Escalade, Escalade ESV, Escalade EXT
2011 Chevrolet Avalanche, Colorado, Silverado, Suburban, Tahoe
2011 GMC Canyon, Sierra, Yukon, Yukon XL

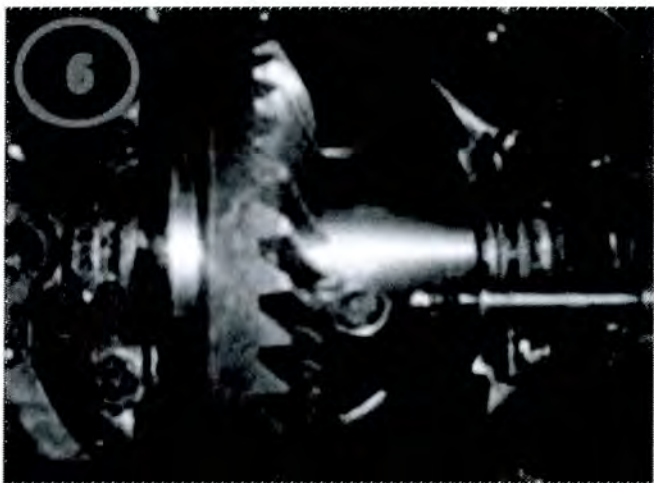
Note: If **BOTH** lines are not clearly visible on the cross pin, the cross pin **MUST** be replaced.

- If the head of the rear axle cross pin has orange and black paint marks or blue and black paint marks, do **NOT** replace the cross pin. Refer to illustration. Proceed to Step 14.
- If the head of the rear axle cross pin does **NOT** have a clearly visible orange and black paint mark, or a blue and black paint mark, (**BOTH** lines **MUST** be clearly visible), **REPLACE** the rear axle cross pin. Refer to illustration. Proceed to Step 10.

10. Remove the lock screw with a ratchet with a 5/16" hexagonal socket while holding the cross pin with a magnet. Dispose of the lock screw.
