CERTAIN 1999-2003 MODEL YEAR WINDSTAR VEHICLES OPERATED IN CORROSION STATES — SUBFRAME FRONT LOWER CONTROL ARM REAR ATTACHING FLANGES AND REAR BODY MOUNT ATTACHMENTS INSPECTION AND REPAIR

Interim Service Procedure

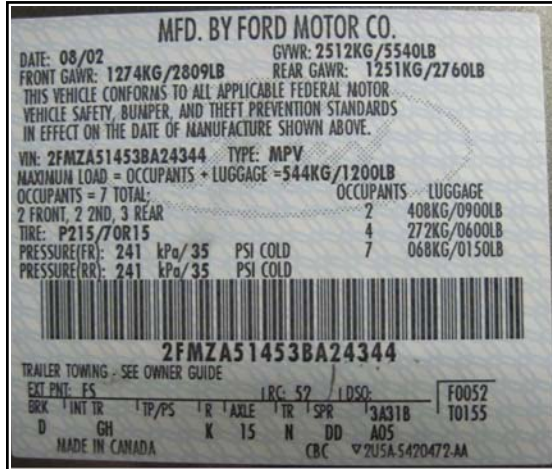
FIGURE 1

- One picture of the Vehicle Certification (VC) Label showing the Vehicle Identification Number (VIN). See Figure 1.
- One picture of the vehicle from the rear passenger side. Picture must clearly show the trim level of the vehicle. See Figure 2.
