Recall Bulletin

PRODUCT SAFETY RECALL

SUBJECT: Rear Suspension Toe Link Separation

MODELS: 2009-2010 Cadillac CTS

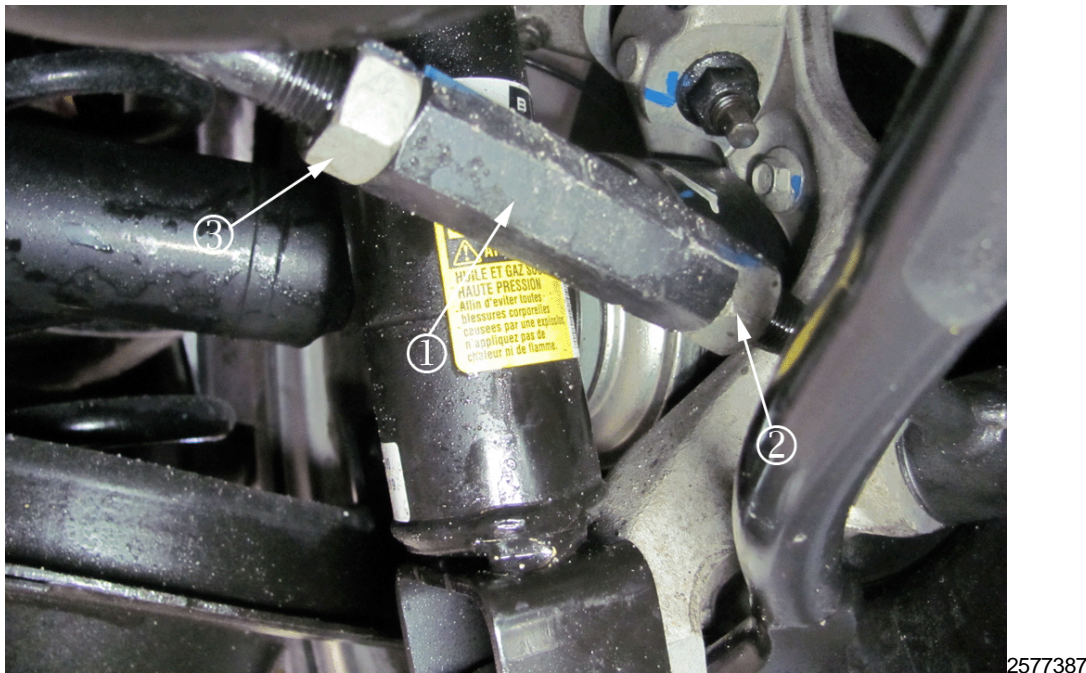
The Toe Link Assembly Includes a (1) Rear Suspension Adjustment Link, (2) Outside Jam Nut (3), Inside Jam Nut and Inside and Outside Toe Link Rods.

3. Locate the rear suspension adjustment links (1).

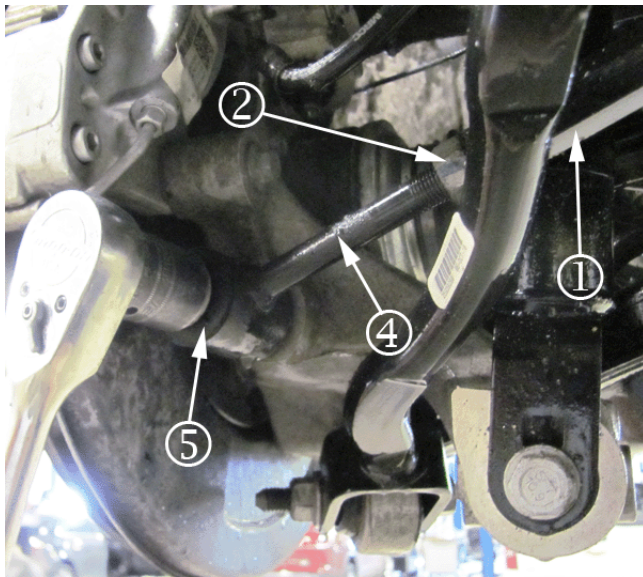
2577397

(1) Rear Suspension Adjustment Link (2) Outside Jam Nut (4) Outside Toe Link Rod (5) Bolt

5.2 Remove the bolt (5) from the toe link assembly-to-knuckle joint (outside joint).
