NOTICE: Revised Defect Information Notice – concerning Spindle Nuts and Stake Washer on certain ArvinMeritor TL Series trailer axles.

ArvinMeritor File: C11AB

NHTSA File: 10E-058

Procedures and Intervals to Inspect the Wheel Ends and Tighten the Spindle Nuts on Meritor TL Series Trailer Axles with Unitized Wheel Ends

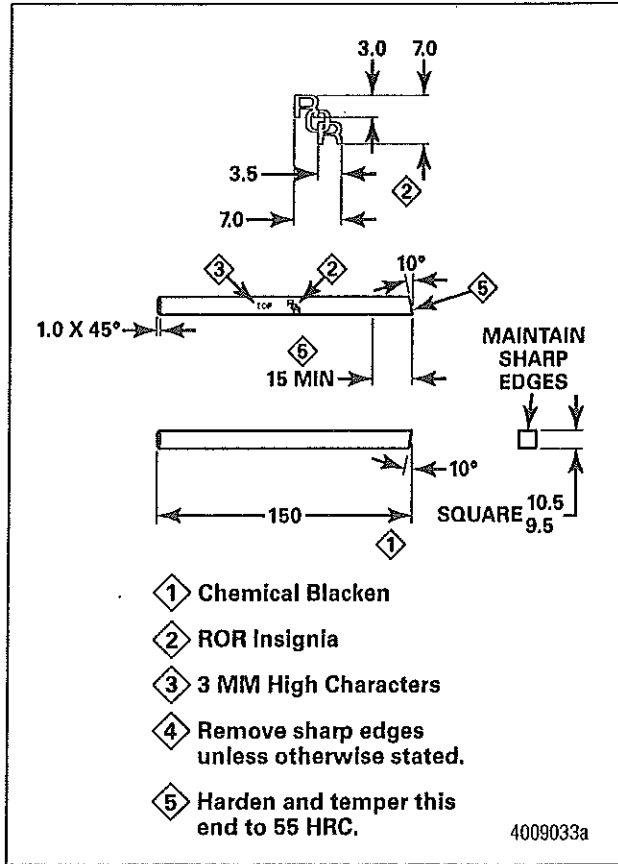
Figure 13

Staking Service Tool

9. Use a hammer and staking tool (Figure 13) to stake the stake washer to the spindle nut in **three** positions. Bend the washer to the stake profile as shown. Figure 3 and Figure 4.

9. Use a hammer and staking tool (Figure 13) to stake the stake washer to the spindle nut in **three** positions. Figure 10 and Figure 11.
