## ABS WIRING UPDATE PROCEDURE

Stoneridge Instrument Cluster ABS  
Malfunction Indicator Noncompliance

# RECALL

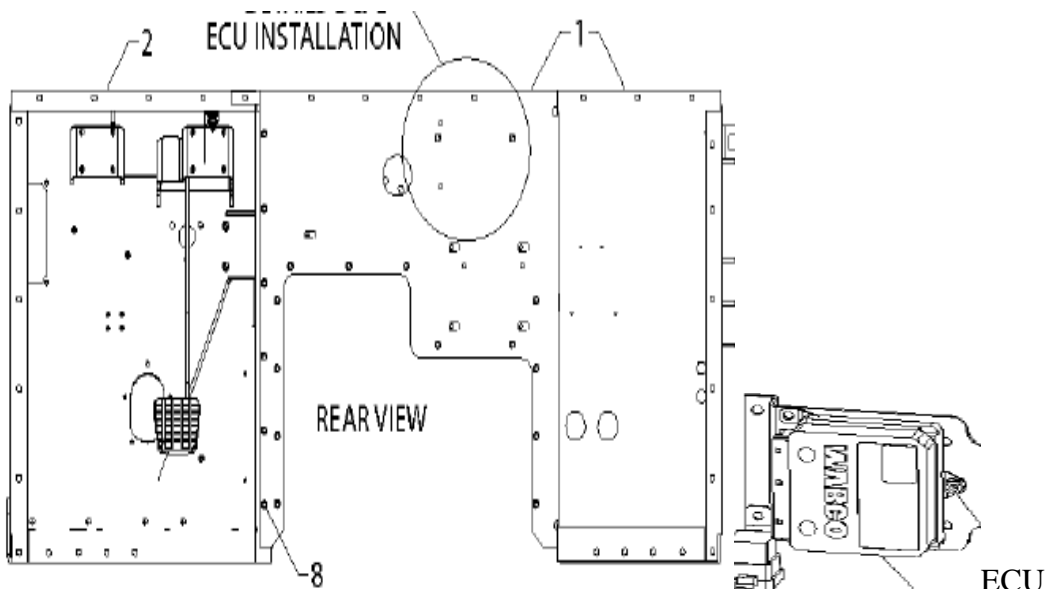
Thumb screws.  
Cover is located  
lower center of  
dash.

1. Park the bus on a level surface, apply parking brakes, turn off engine and remove keys. Chock wheels.
2. Disconnect batteries – Note; When disconnecting the batteries, remove the negative cable first.
3. Remove chassis Power Distribution Unit (PDU) cover by removing two thumb screws. The thumb screws are located at the top of each side of the cover.
