File In Section: Product Recalls  
Bulletin No.: 11142B  
Date: June 2011

# Recall Bulletin

**SUBJECT:** Shift Lever May Not Display Correct Gear

**MODELS:** 2011 Chevrolet Cruze  
Equipped with an Automatic Transmission

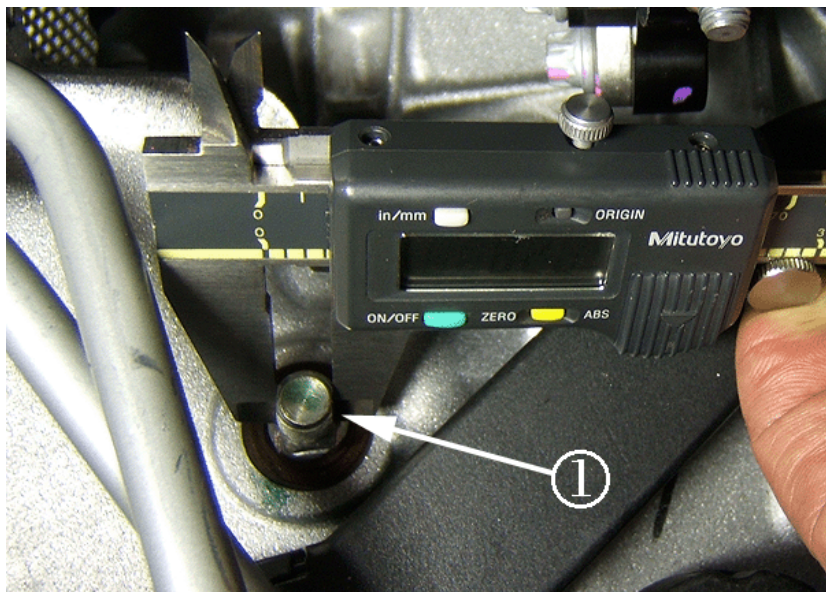
2650652

16. Remove and examine the transmission range selector lever. Confirm that the rectangular receiver in the lever has not been deformed. It is expected that a witness mark (1) on the bottom of the lever may exist (as shown) from contact with the now removed burr. Minor marks at the edge of the receiver will not affect proper operation. Only replace the lever if significant (easily seen) deformation / rounding of the receiver hole exists
