# TECHNICAL SERVICE BULLETIN

V-11-01

V-11-01A

### SUBJECT: 2011 Cross Country Handlebar Riser Assembly Inspection / Replacement

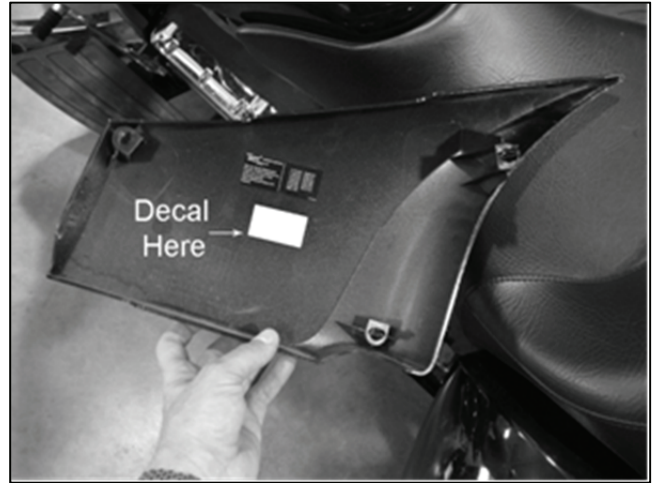
A Service Bulletin Completion Decal must be completed for this bulletin repair. Place the decal on the unit as shown (inside LH side cover). If you require more decals, order them through normal Polaris parts ordering channels.
