## FUSE BOX CONNECTIONS • INSPECT AND TORQUE TIGHTEN 9700 (B13R)

### MODEL YEAR(S) AND VEHICLES INVOLVED

Model Year 2009 to 2011 incl.	From chassis 127142 up to 148659 incl.
----------------------------------	--

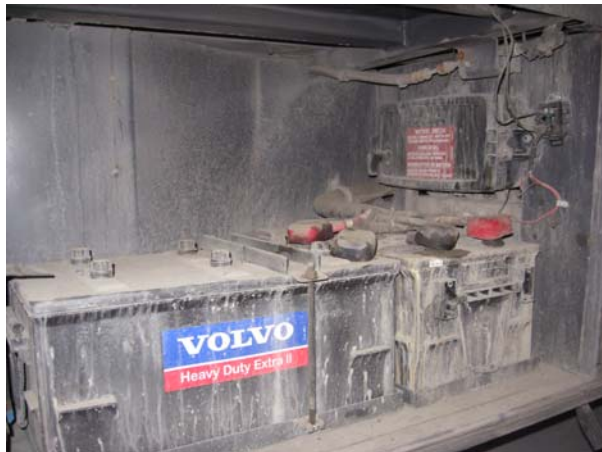
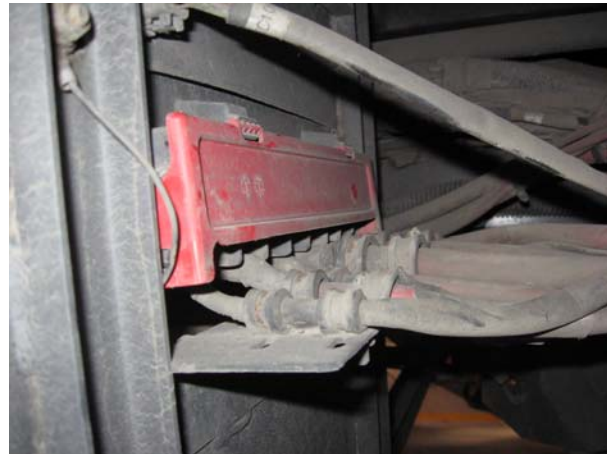
1. Open battery compartment.

2. Check for any damages, inspect and torque tighten all cable connections on front fuse box. See method below. Check also clamping to the bracket of all connected cables and remedy when necessary.

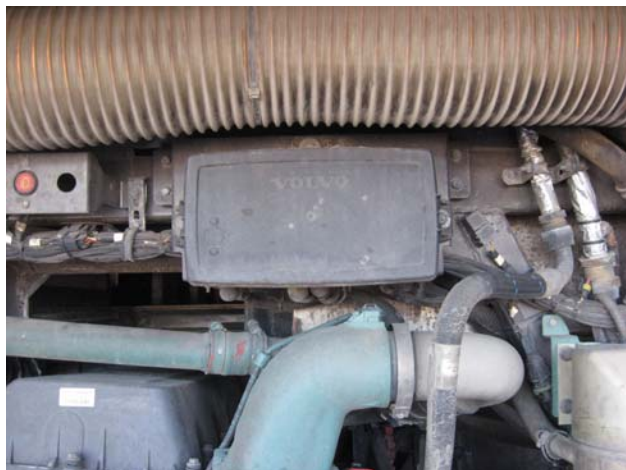
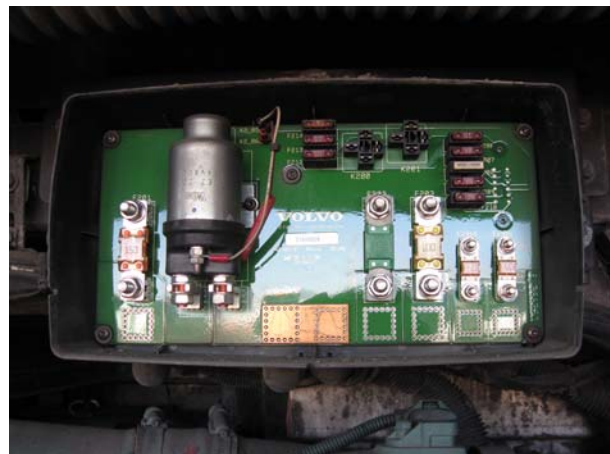
3. Open engine compartment door.

4. Check for any damages, inspect and torque tighten all cable connections on rear fuse box. Check also clamping to the bracket of all connected cables and remedy when necessary.
