Audi

Safety Recall

Code: 20Q8

Subject: 2011 – 2012 model year Audi R8 Spyder
Fuel Supply Line

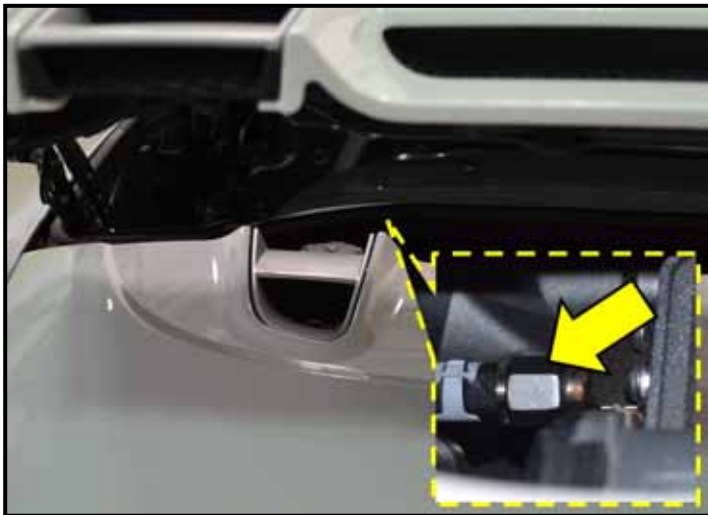
! Note: As fuel line is tightened, clearance is affected. Adjustment may take several attempts

i Tip: May require the aid of a second technician to hold fuel line in place while torque is applied to fitting
