SIB 63 06 11

2025-02-20

**RECALL 11V-438: REPAIR GROUND CABLE FOR THE OUTER TAILLAMPS**

E-Series	Model Description	Production Date
E46	3 Series Sedan	9/01/2001 – 02/01/2005

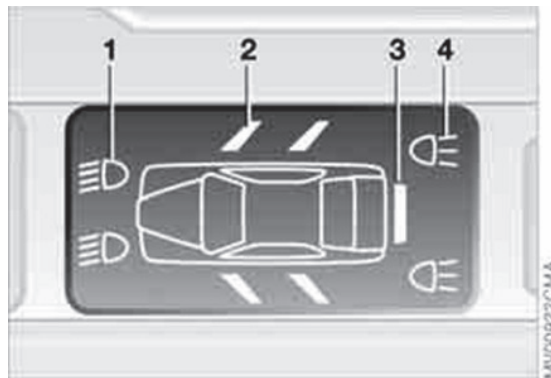
- 1. If the vehicle is experiencing this condition, a number of visual and audible warnings are provided. If the condition involves the tail lamp or brake lamp, then a warning symbol is provided in the vehicle's "message center" in the instrument panel. Item 2 below contains an image, from the Owner's Manual, of the warning symbol. If the condition involves the turn signal, then the turn signal symbol in the instrument panel flashes (and sounds) at twice its normal frequency. In addition, each time the vehicle is started, an audible signal is made.**
- 2. The image below, from the Owner's Manual, depicts the warning symbol (see icon "4") that is displayed in the vehicle's "message center" in the instrument panel if the tail lamp or brake lamp is experiencing this condition.**

- 3. If one of the tail lamp warning symbols appear (4), please drive carefully and rear lamps are not working.**
- 4. If this condition is present, and if you feel unsafe, please contact BMW Roadside Assistance at 1-800-332-4269 immediately to have your vehicle brought to the nearest Authorized BMW Center.**
- 5. BMW recommends that you always wear your safety belt, and that all passengers are properly seated and restrained at all times.**
- 6. If you are not the only driver of this vehicle, please advise all other drivers and passengers of this important information.**

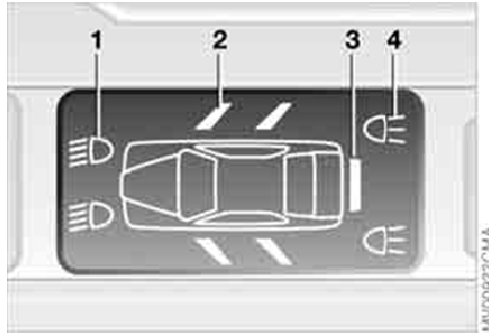
- 1. CONTACT YOUR AUTHORIZED BMW CENTER IMMEDIATELY TO HAVE THE NECESSARY REPAIR PERFORMED AS SOON AS POSSIBLE.**
- 2. If the vehicle is experiencing this condition, a number of visual and audible warnings are provided. If the condition involves the tail lamp or brake lamp, then a warning symbol is provided in the vehicle's "message center" in the instrument panel. Item 3 below contains an image, from the Owner's Manual, of the warning symbol. If the condition involves the turn signal, then the turn signal symbol in the instrument panel flashes (and sounds) at twice its normal frequency. In addition, each time the vehicle is started, an audible signal is made.**
- 3. The image below, from the Owner's Manual, depicts the warning symbol (see icon "4") that is displayed in the vehicle's "message center" in the instrument panel if the tail lamp or brake lamp is experiencing this condition.**

4. **If one of the tail lamp warning symbols appear (4), please drive carefully and cautiously, as the driver of the vehicle behind you may not notice that one of the rear lamps are not working.**
5. **If this condition is present, and if you feel unsafe, please contact BMW Roadside Assistance at 1-800-332-4269 immediately to have your vehicle brought to the nearest authorized BMW center.**
6. **BMW recommends that you always wear your safety belt and that all passengers are properly seated and restrained at all times.**
7. **If you are not the only driver of this vehicle, please advise all other drivers and passengers of this important information.**
