GROUP Campaign	MODEL 2007/08MY Rondo (UN), 2006/08 Optima (MG)
	NUMBER 094	DATE February 2012
SAFETY RECALL CAMPAIGN		
SUBJECT: RONDO & OPTIMA CLOCK SPRING ASSEMBLY REPLACEMENT (SC094)

Rondo & Optima Clock Spring Assembly

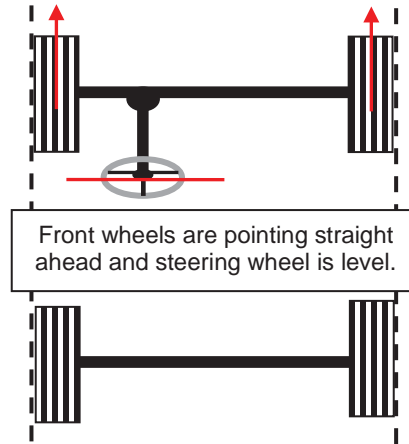
1. Drive vehicle into the shop and make sure the front wheels are pointing straight ahead and the steering wheel is straight and level before performing the service procedure.

Front wheels and steering wheel must be straight to ensure proper installation of the clock spring assembly.
