Audi

# Safety Recall

Code: 23J8

Subject: 2010-2012 Model Year A3  
Diesel Fuel Injection Lines

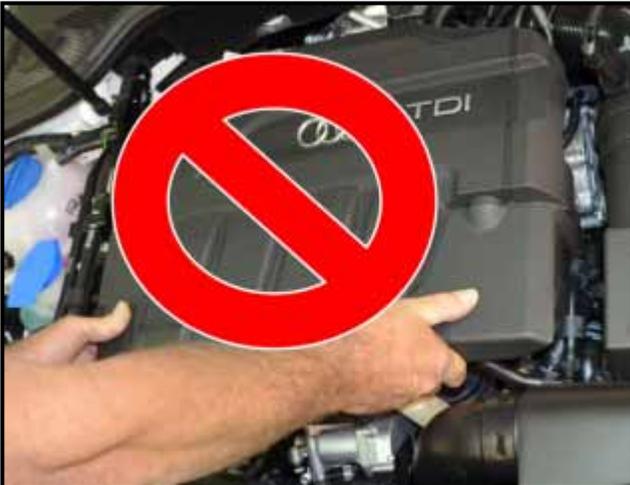
DO NOT remove engine cover by pulling from the front <as shown> as this will result in damage to engine cover that is not covered under this action

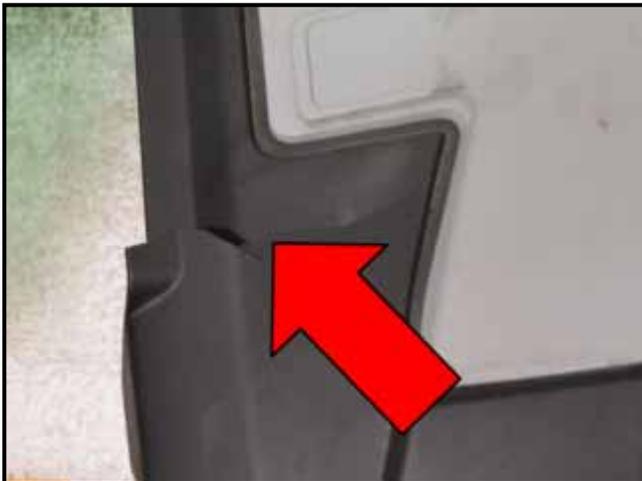
Example of damaged engine cover <arrow> due to improper removal. This type of damage is not covered under this action

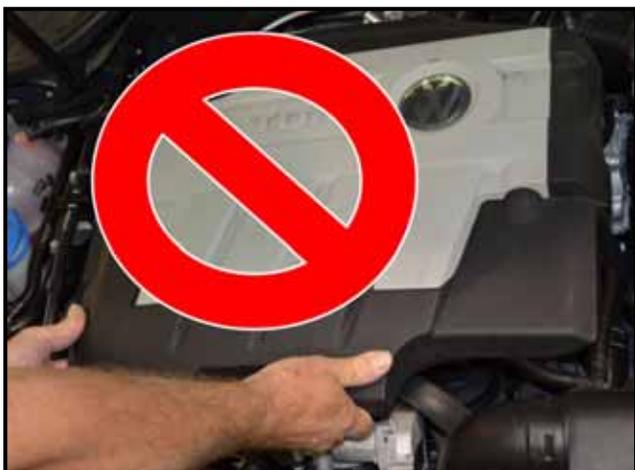
Note:  
DO NOT remove engine cover by pulling from the front <as shown> as this will result in damage to engine cover that is not covered under this action

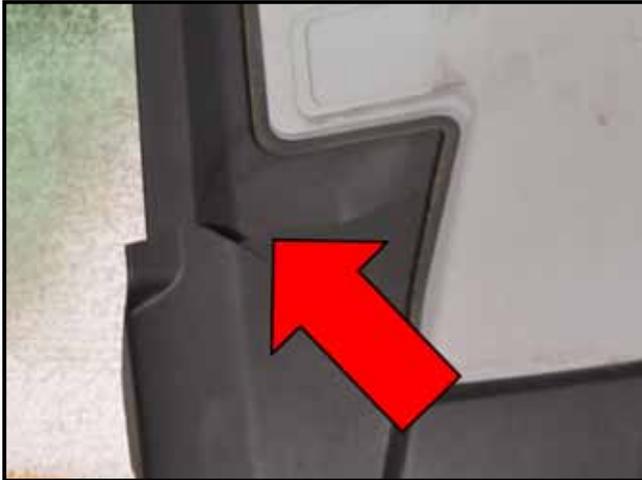
Example of damaged engine cover <arrow> due to improper removal. This type of damage is not covered under this action
