Safety Recall

Code: 23J8

**Subject: 2010-2012 Model Year A3
Diesel Fuel Injection Lines**

October 4 2011

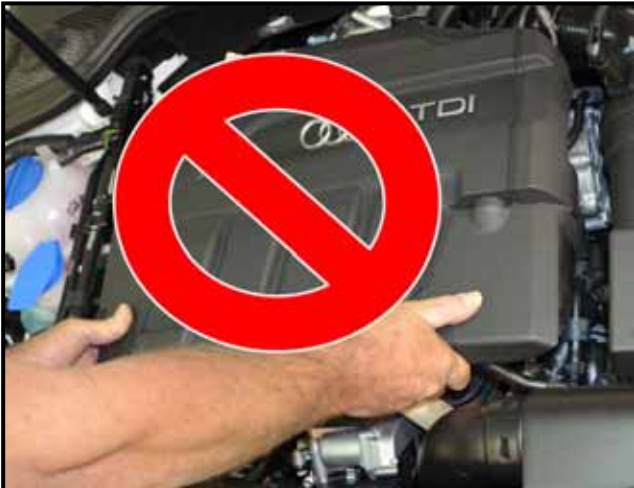
DO NOT remove engine cover by pulling from the front <as shown> as this will result in damage to engine cover that is not covered under this action
