Michael A. Berardi
 Director
 Service Engineering Operations
 Ford Customer Service Division

August 28, 2015

SUBJECT: **Safety Recall 11S16 – Supplement #9**
 Certain 1999-2003 Model Year Windstar Vehicles Operated in Corrosion States
 Subframe Front Lower Control Arm Rear Attaching Flanges and Rear Body Mount
 Attachments Inspection and Repair

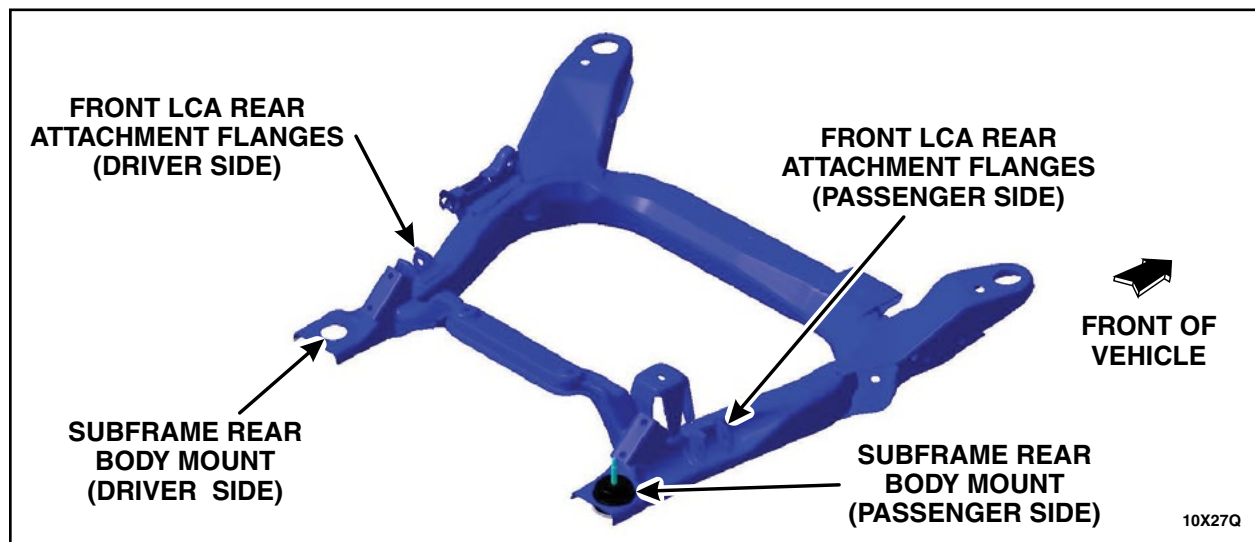
FIGURE 1

- both flanges at the LCA rear attachment point are completely missing.
- LCA rear attachment points that have non-factory welded flanges or non-factory flange reinforcements.

NOTE: If installing reinforcement brackets, at least a portion of one flange must be present to properly locate the reinforcement bracket.

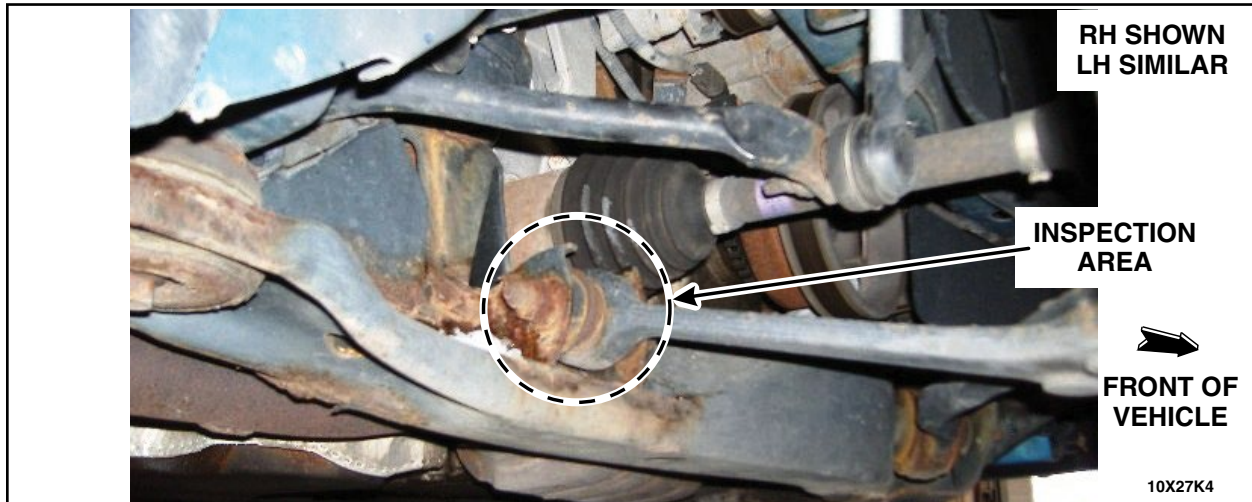
FIGURE 1

3. Inspect both surfaces of the LCA rear attachment flanges on the driver and passenger side of the subframe for cracks, perforations, excessive loss of metal, non-factory welded flanges or reinforcements. See Figures 2, 3, 4 and 5.

1. Remove both front wheels. For additional information, refer to the WSM, Section 204-04.
2. Using a hand-held wire brush, clean all loose rust, scale, and debris from both surfaces of the driver and passenger side of the subframe lower control arm (LCA) rear attachment flanges. See Figure 1.

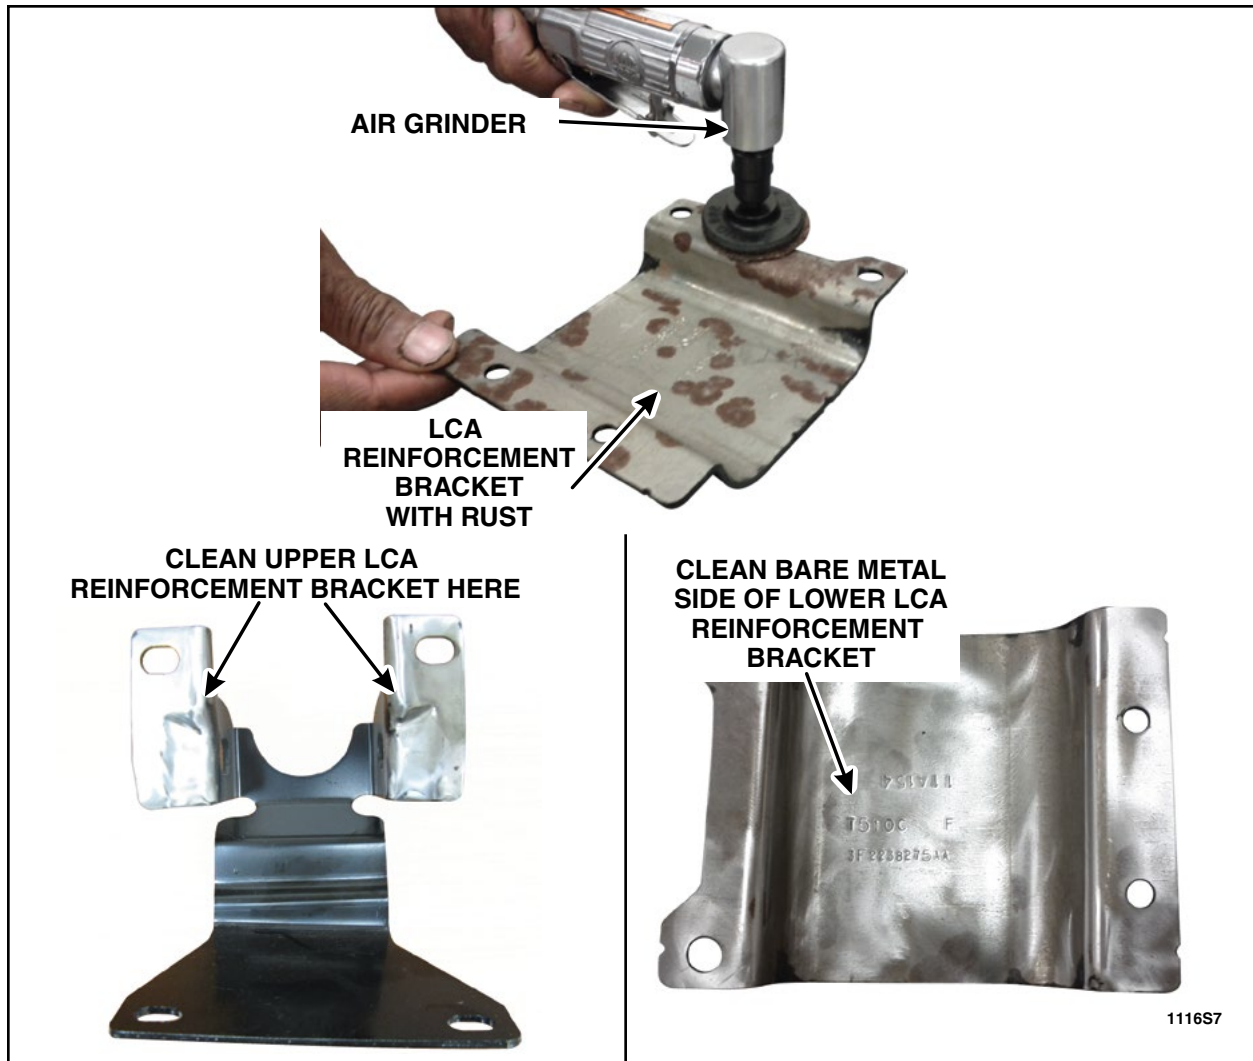
FIGURE 11

12. **NOTICE:** The adhesive will not bond properly if the reinforcement brackets have any rust on them. Failure to clean the reinforcement brackets will prevent the adhesive from bonding properly.

Using an air grinder and a 50 mm (2 in) diameter coarse Roloc™ Disc or equivalent, remove any rust from all 4 LCA reinforcement brackets. See Figure 11.

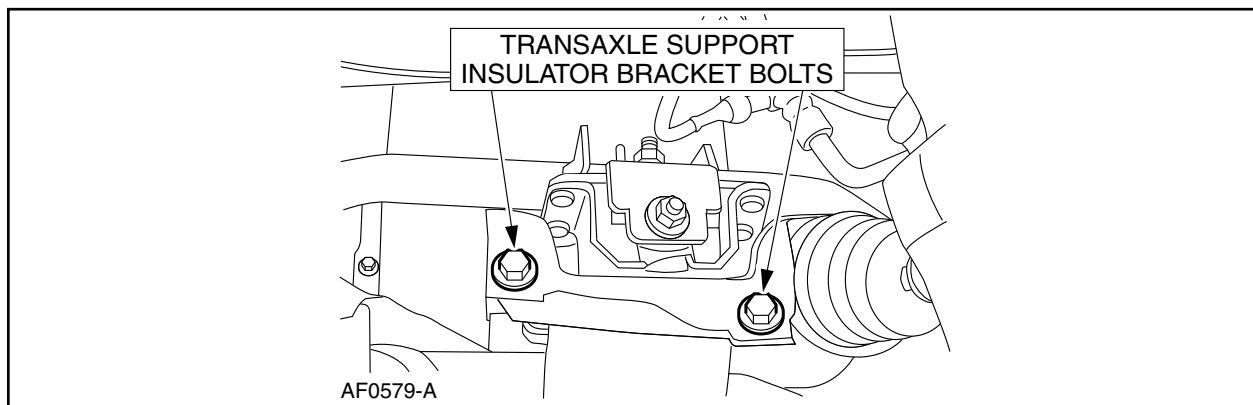
FIGURE 8

13. Remove the two bolts securing the transaxle support insulator bracket to the subframe. See Figure 8.

- To install, tighten to 80 Nm (59 lb-ft).

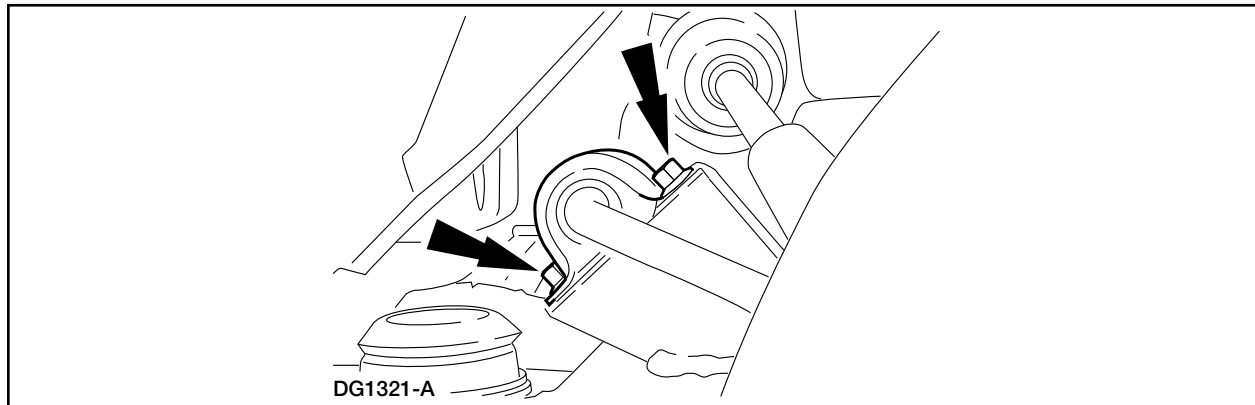
FIGURE 9

19. Remove the four stabilizer bar bracket insulator bolts. See Figure 9.

- To install, tighten to 51 Nm (38 lb-ft).

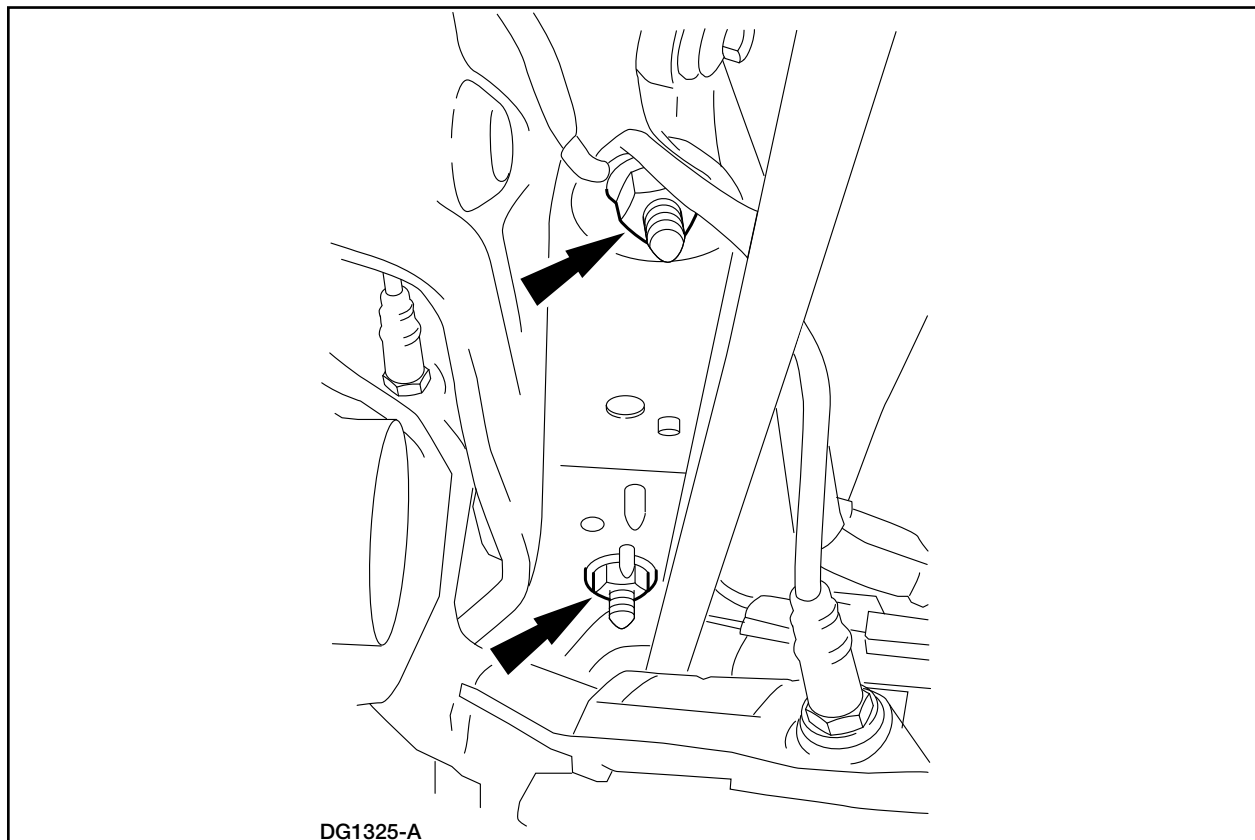
FIGURE 10

20. Remove the steering gear nuts. See Figure 10.

- To install, tighten to 125 Nm (92 lb-ft).
