TMS-NTC-12278
November 20, 2012

Re: Toyota Safety Recall 12V-373 – Supplemental Dealer Notification

**Subject: Safety Recall CLE-Remedy Parts Available
2010 Model Year HS 250h Vehicles
Rear Lower Suspension Arm No. 1**

**2010 Model Year HS250h Vehicles
Rear Lower Suspension Arm No. 1
SAFETY RECALL NOTICE (Remedy Now Available)**

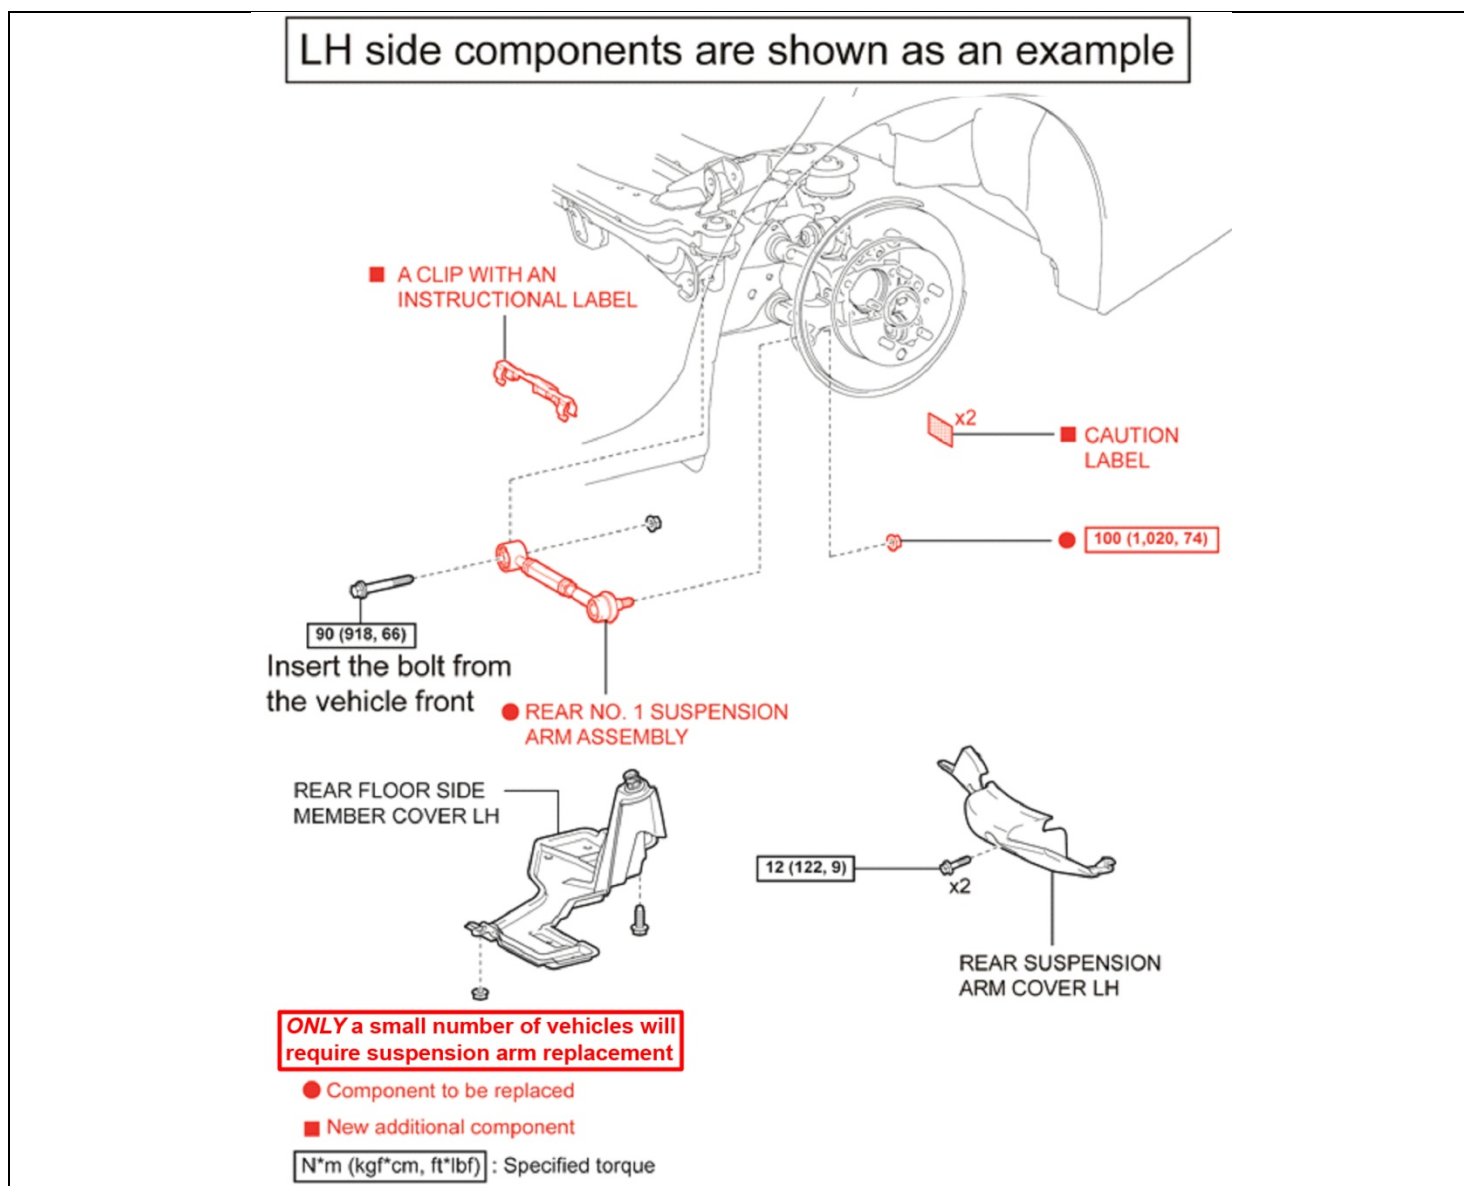
V. COMPONENTS

In the Rear Suspension Arm No.1 Assembly ("arm"), if the nuts for adjusting the rear wheel alignment are not tightened following the proper procedure and torque specification when vehicle alignment service is performed, backlash may develop at the thread portion of the arm (shaft and turn-buckle), followed by formation of rust. If this occurs, threads may wear, causing the arm to separate, which could result in the loss of vehicle control.
