Re: Toyota Safety Recall 12V-373 – Interim Dealer Notification

Subject: Safety Recall CLE (Interim C2E) -Interim Notification
2010 Model Year HS 250h Vehicles
Rear Lower Suspension Arm No. 1

INTERIM TECHNICAL INSTRUCTIONS
FOR
SAFETY RECALL CLE **INTERIM C2E**
REAR LOWER SUSPENSION ARM No.1
CERTAIN 2010 MODEL YEAR HS250h

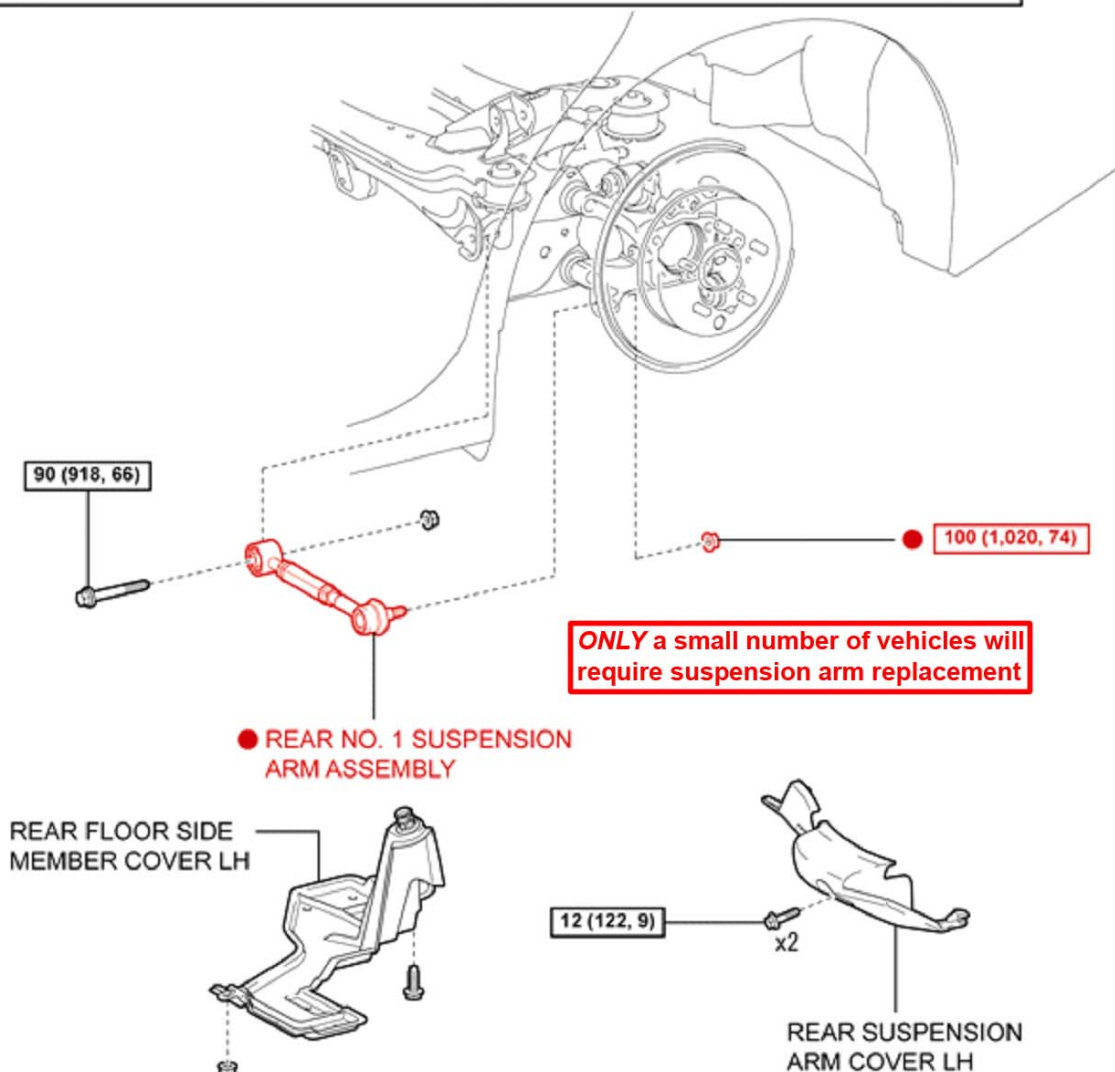
V. COMPONENTS

A1: In the Rear Suspension Arm No.1 Assembly ("arm"), if the nuts for adjusting the rear wheel alignment are not tightened following the proper procedure and torque specification when vehicle alignment service is performed, backlash may develop at the thread portion of the arm (shaft and turn-buckle), followed by formation of rust. If this occurs, threads may wear, causing the arm to separate, which could result in the loss of vehicle control.

LH side components are shown as an example

● Replacement part

N*m (kgf*cm, ft*lb) : Specified torque
