Re: Toyota Safety Recall 12V-373 – Interim Dealer Notification

Subject: Safety Recall C0J – (C1J) *Interim Notification*

2006 to Early 2011 Model Year RAV4 Vehicles

Rear Lower Suspension Arm No.1

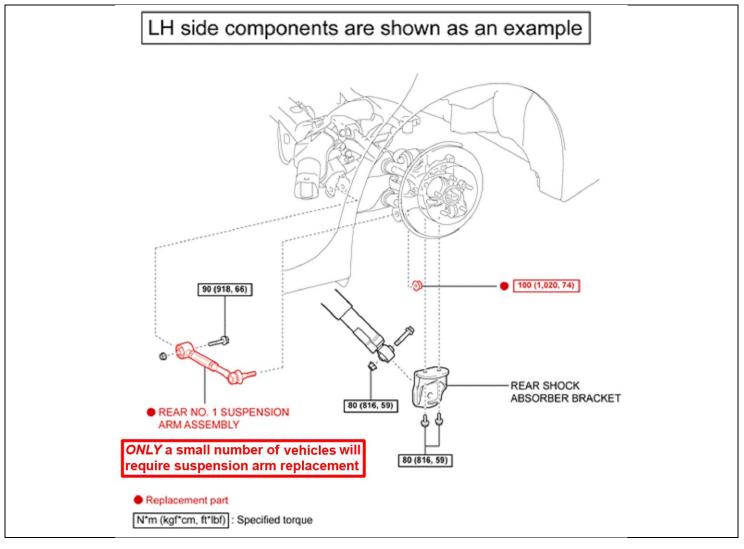
V. COMPONENTS

In the Rear Suspension Arm No.1 Assembly ("arm"), if the nuts for adjusting the rear wheel alignment are not tightened following the proper procedure and torque specification when vehicle alignment service is performed, rust may form on the arm. If this occurs, threads may wear, causing the arm to separate, which could result in the loss of vehicle control, increasing the risk of a crash.
