TMS-NTC-12251  
October 29, 2012

Re: Toyota Safety Recall 12V-491 – Dealer Notification (Remedy)

Subject: Safety Recall - C0M **Remedy Notification**  
Multiple Models and Model Years  
Power Window Master Switch (PWMS)

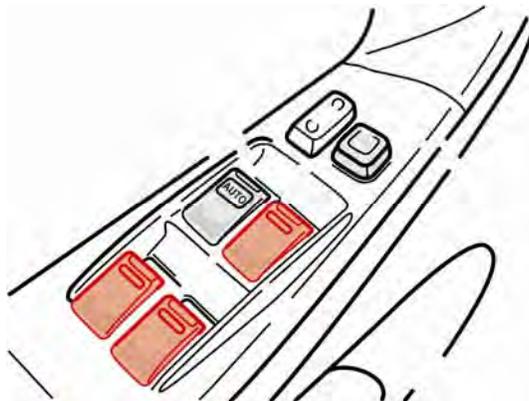
We appreciate your patience while we prepare the remedy. Over time, the passenger window switches in the PWMS assembly may begin to feel uneven or "notchy" when they are operated. This may be an indication that your switch is not operating properly. Please make an appointment as soon as possible with your Toyota dealership to have the PWMS assembly inspected. If it is determined that the switch is not operating due to this condition, the assembly will be repaired at **NO CHARGE** to you.

In the meantime, do not attempt to make repairs by applying commercially available chemicals (for example, lubricants or cleaners) into the PWMS assembly. Doing so may cause the PWMS assembly to smoke, melt or under some circumstances cause a fire. In the event commercially available chemicals have already been applied to the PWMS assembly, please make an appointment with your dealer as soon as possible to have the PWMS assembly inspected.

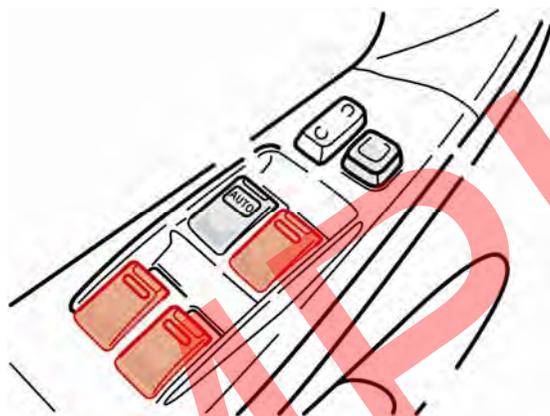
The Power Window Master Switch assembly (“PWMS assembly”) which controls the windows for the driver and passengers is located in the driver’s door. The switches that control the **passengers’ windows** in this assembly may overheat and possibly cause a fire.

Any authorized Toyota dealer will inspect the PWMS assembly and apply a specialized grease. In a limited number of instances, based upon the results of the inspection, the PWMS assembly circuit board may also be replaced. This inspection and repair will be performed at **NO CHARGE** to you.

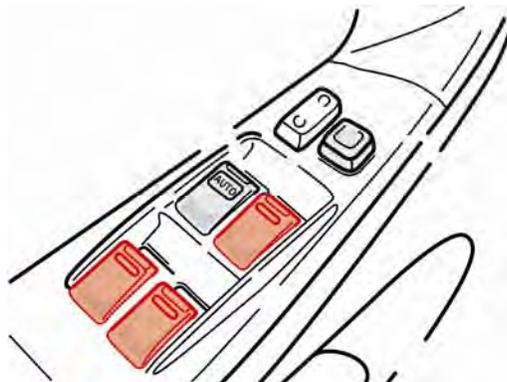
We appreciate your patience while we prepare the remedy. Over time, the passenger window switches in the PWMS assembly may begin to feel uneven or "notchy" when they are operated. This may be an indication that your switch is not operating properly. Please make an appointment as soon as possible with your Scion dealership to have the PWMS assembly inspected. If it is determined that the switch is not operating due to this condition, the assembly will be repaired at **NO CHARGE** to you.

In the meantime, do not attempt to make repairs by applying commercially available chemicals (for example, lubricants or cleaners) into the PWMS assembly. Doing so may cause the PWMS assembly to smoke, melt or under some circumstances cause a fire. In the event commercially available chemicals have already been applied to the PWMS assembly, please make an appointment with your dealer as soon as possible to have the PWMS assembly inspected.

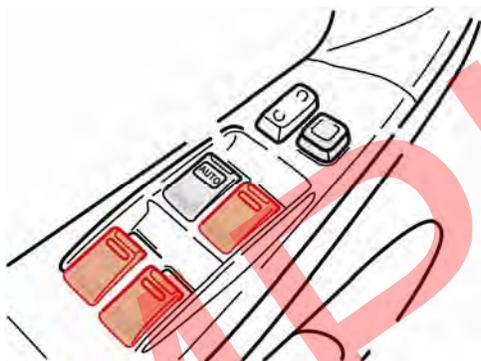
The Power Window Master Switch assembly (“PWMS assembly”) which controls the windows for the driver and passengers is located in the driver’s door. The switches that control the **passengers’ windows** in this assembly may overheat and possibly cause a fire.

Any authorized Scion dealer will inspect the PWMS assembly and apply a specialized grease. In a limited number of instances, based upon the results of the inspection, the PWMS assembly circuit board may also be replaced. This inspection and repair will be performed at **NO CHARGE** to you.
