Re: Toyota Safety Recall 12V-491 – Preliminary Dealer Notification

Safety Recall - C0M (C1M) *Preliminary Notification*

Multiple Models and Model Years
 Power Window Master Switch (PWMS)

SAFETY RECALL C0M

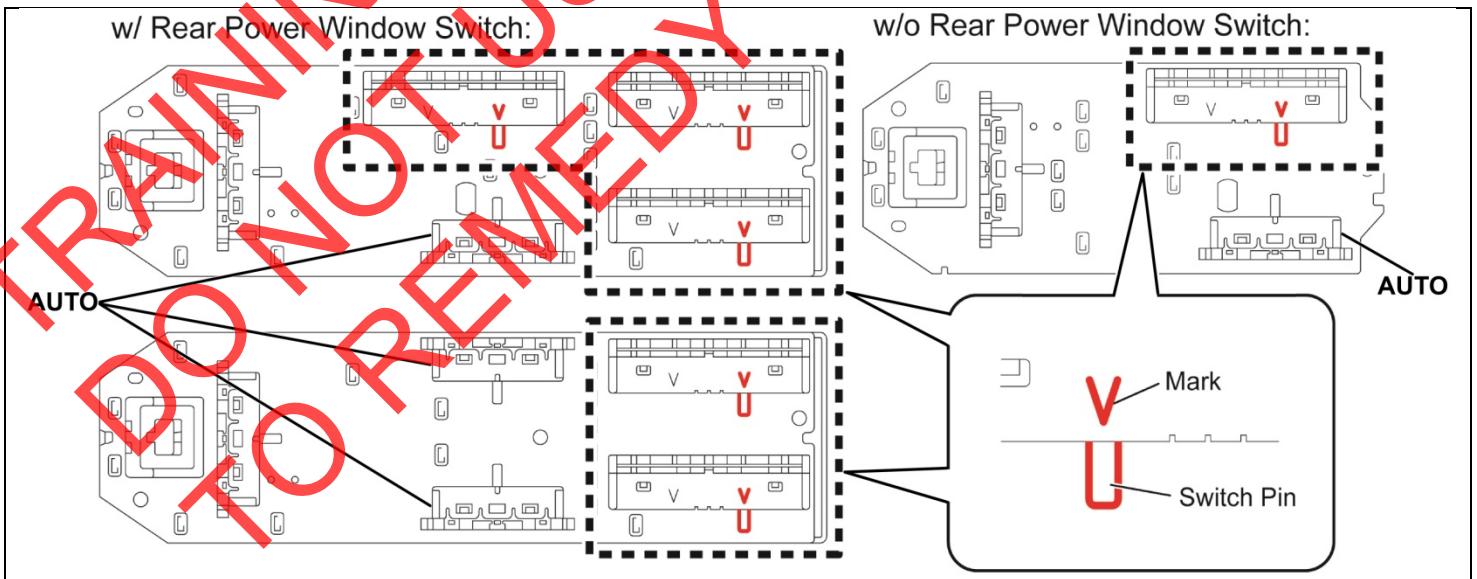
| CONDITION | ACTION REQUIRED |
|---|--|
| One or more resistance value IS NOT infinite. | Replace the power window master switch circuit board. Proceed to SECTION X SWITCH REASSEMBLY NOTE: <ul style="list-style-type: none">• Mark the NG circuit board with an 'X' so that it is not reused.• There is NO NEED to apply grease to the new circuit board. |

- The switches **MUST** be in this position when checking the resistance. This is the OFF position, if the switch is in any other position, the reading will be incorrect.
- ALL** switches that **ARE NOT** AUTO **MUST** be checked.

b) Measure the resistance between points A-B and points B-C.

NOTE: Set the DVOM to maximum resistance range.

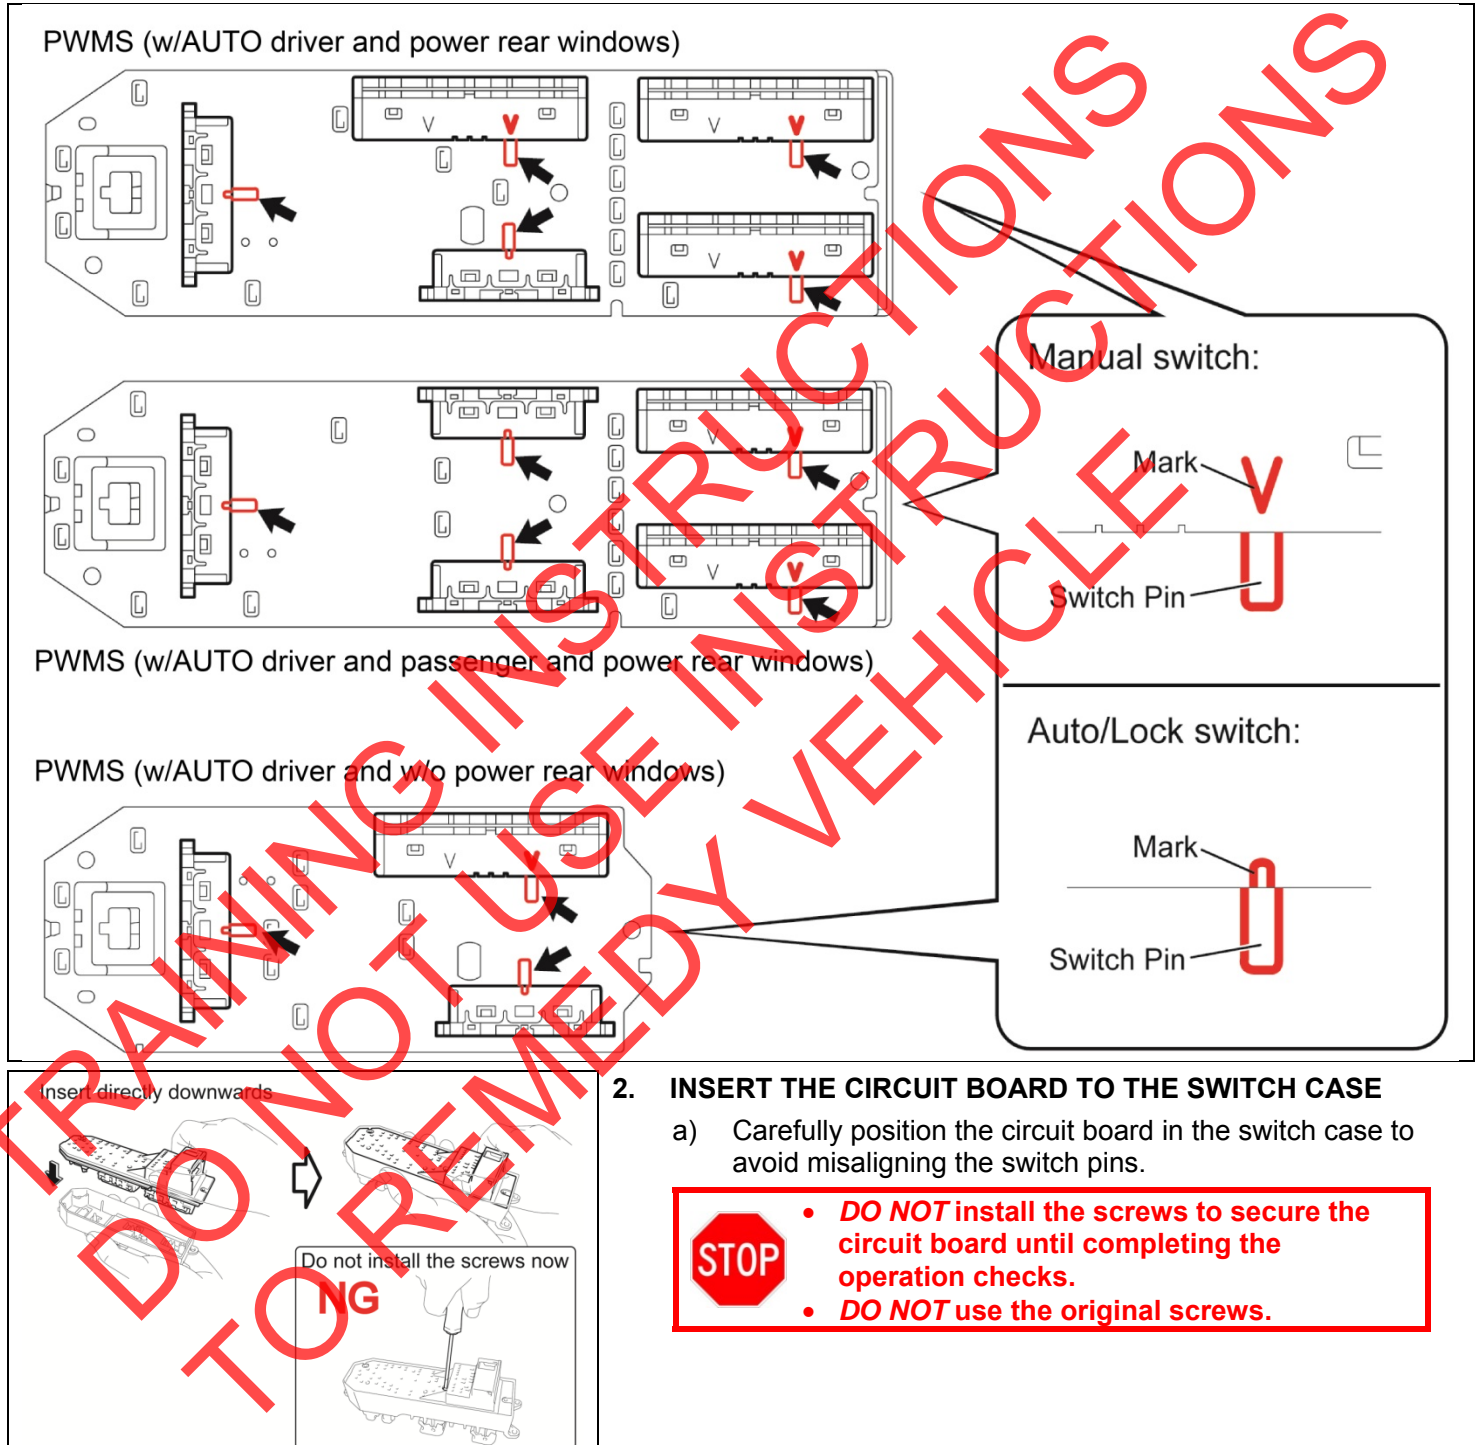
- Complete this section if grease application has been completed or if the circuit board is being replaced.
- If the switch pins are not aligned, the switches will not operate correctly after reassembly.

1. POSITION THE SWITCH PINS

- a) Align all switch pins with the marks as shown in the illustration below.
