TMS-NTC-12277
November 20, 2012

Re: Toyota Safety Recall 12V-528 – Dealer Notification Remedy

Subject: Safety Recall - C0S **Remedy Notification**
2012 to early 2013 Model Scion iQ Vehicles
Occupant Classification System (OCS)

TECHNICAL INSTRUCTIONS
FOR
SAFETY RECALL C0S
OCCUPANT CLASSIFICATION SYSTEM (OCS)
2012 – EARLY 2013 MODEL YEAR SCION iQ

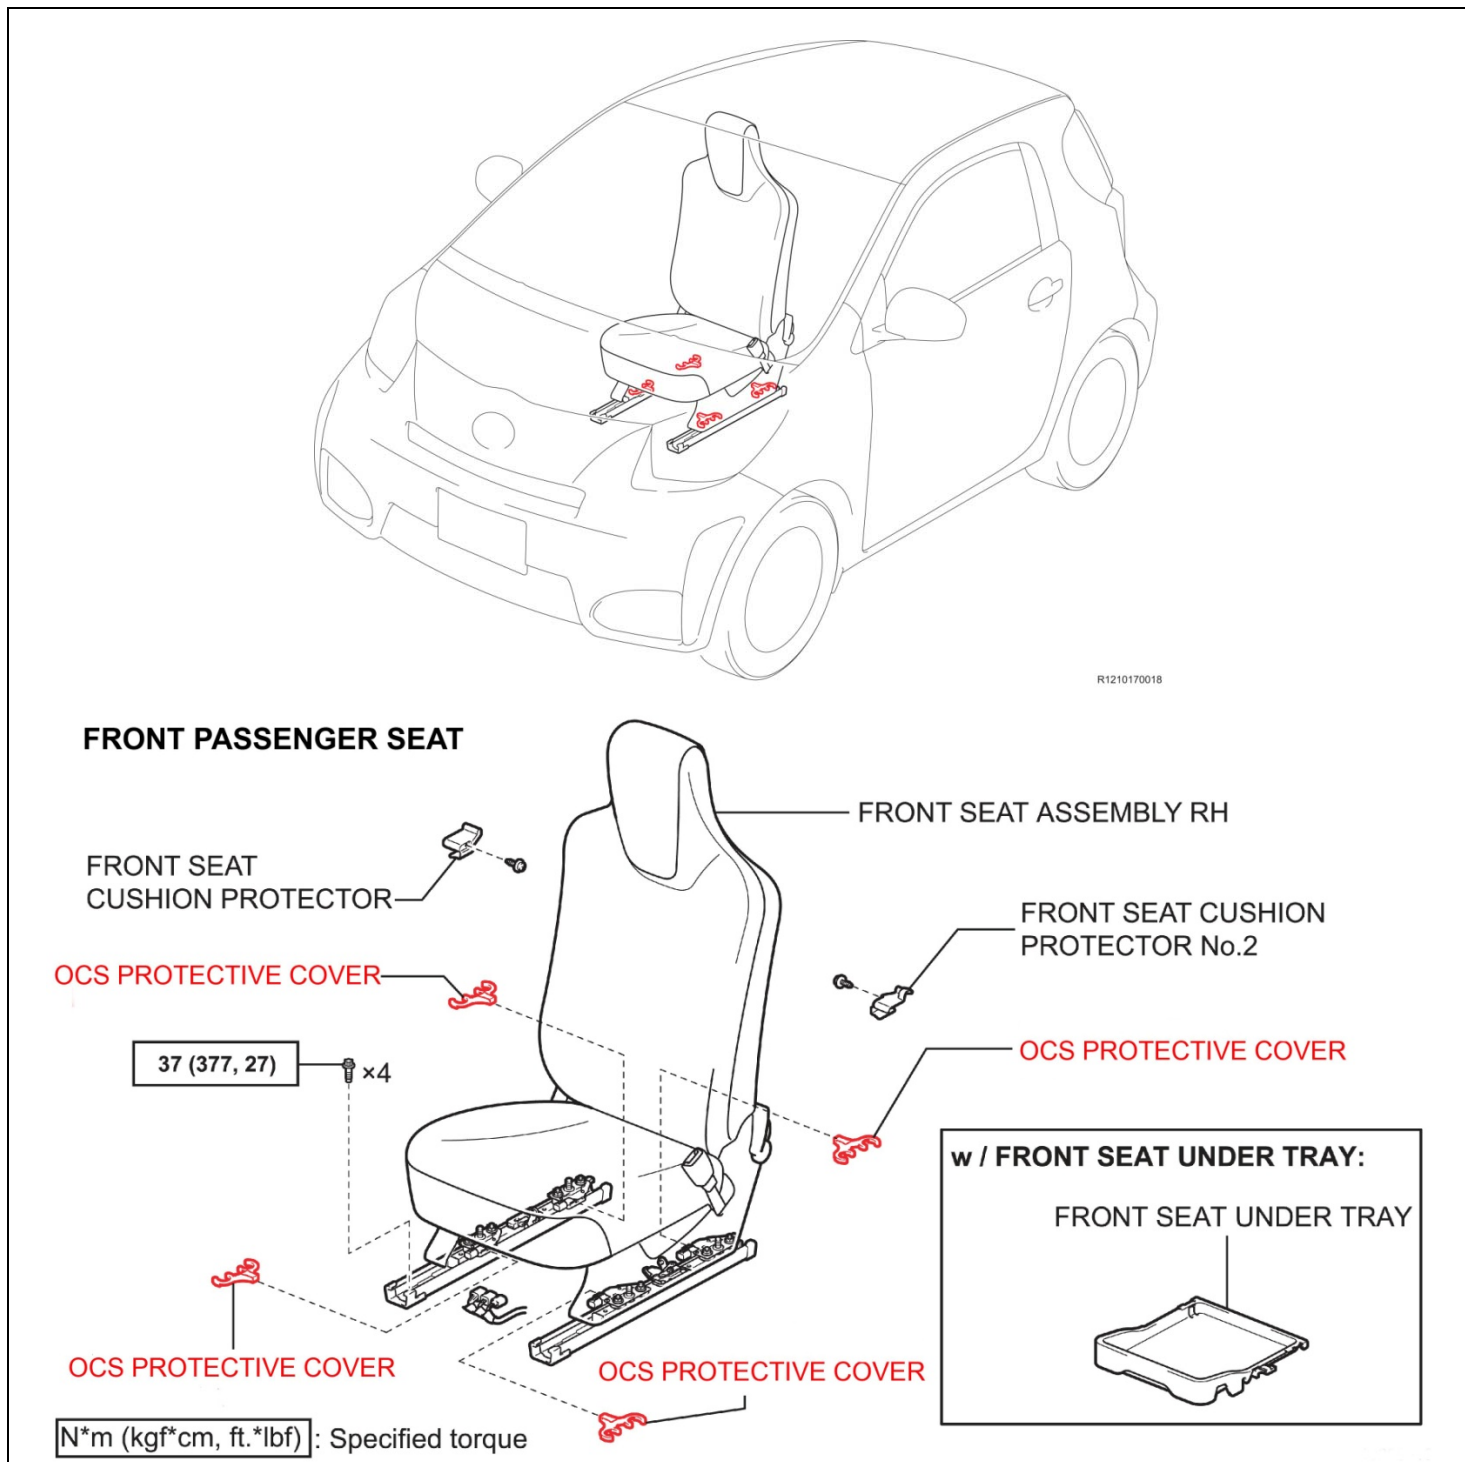
V. COMPONENTS

The front passenger seat assembly of the Scion iQ is equipped with sensors for the Occupant Classification System (OCS) which is used to control the operation of the front passenger Supplemental Restraint Systems (SRS) such as the airbags and seat belt pre-tensioner. Flexible Printed Circuit (FPC) Cables for the sensors located in the seat rail could come into contact with the rear floor mat strap or other object placed near the seat track and become damaged as the front passenger seat slides forward or backward. Depending upon how the FPC cable becomes damaged, the airbags may not deploy as designed or the airbags and seat belt pre-tensioner may be improperly activated. Deactivated or improperly activated air bags could increase the risk of injury to an occupant in the event of a crash.

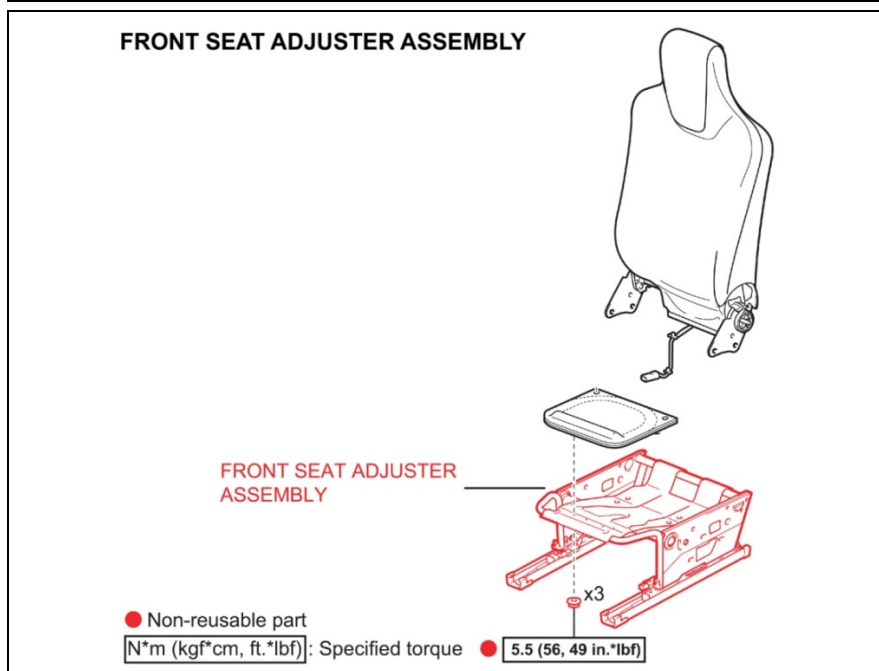
CONDITION	ACTION REQUIRED
Indicator or Light NOT illuminated	Install the four OCS Protective Covers. Proceed to VII. INSTALL THE OCS PROTECTIVE COVERS
SRS Warning Light illuminated	Diagnose as outlined in the repair manual. NOTE: If diagnosis leads to seat adjuster assembly replacement, use the campaign part which already has the protective covers installed. If the seat adjuster assembly is not replaced, proceed to step VII. INSTALL THE OCS PROTECTIVE COVERS
Passenger Airbag ON/OFF Indicator illuminated	Replace the front seat adjuster assembly, then proceed to section VII. STEP 9. REINSTALL THE FRONT SEAT UNDER TRAY Refer to TIS for instructions on front seat adjuster assembly replacement

- Only a small number of vehicles will require replacement of this part.
- The campaign part (P/N 04002-70174) is equipped with OCS Protective Covers.

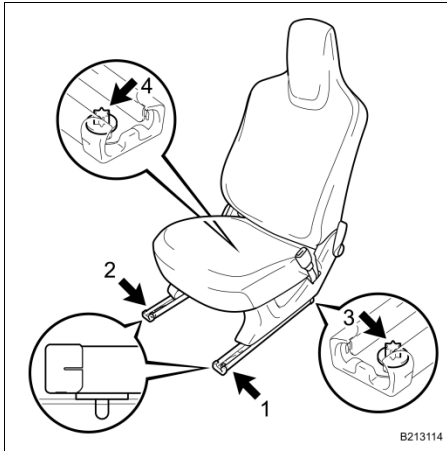
NOTE: If the front seatback is not locked, then seat track may accidentally move during removal and cause damage to interior parts.

NOTE: If the bolts are not tightened in the correct sequence then the calibration may be incorrect.

Torque: 27ft. lbf (37 N·m)
