## SAFETY RECALL G-12529

NOVEMBER 2012

Navistar has decided that a defect which relates to motor vehicle safety exists in certain LoneStar®, ProStar®, and WorkStar® model trucks built 22 April 2012 thru 29 October 2012 with steering wheel feature codes 05CAW, 05CAX, 05CAZ, 05CBA or 05WBD.

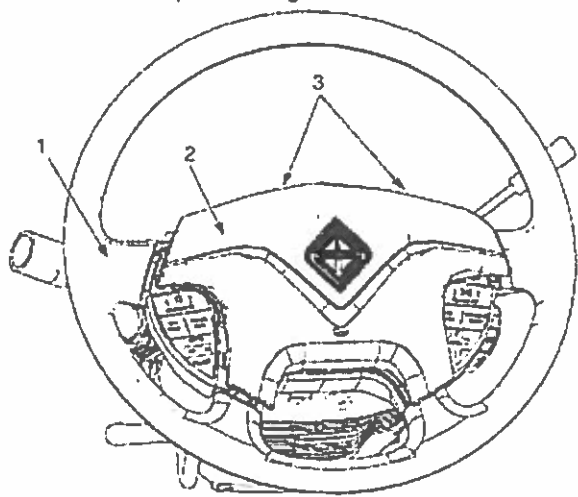
**Figure 1**  
 1 Steering wheel  
 2 Horn Pad  
 3 Top Leading Edge

1. Remove the horn pad by placing both hands on top of the pad and using your fingertips underneath the top edge of the pad to gently pull upward toward you. It is not necessary to remove the electrical connections from the horn pad. See figure 1.

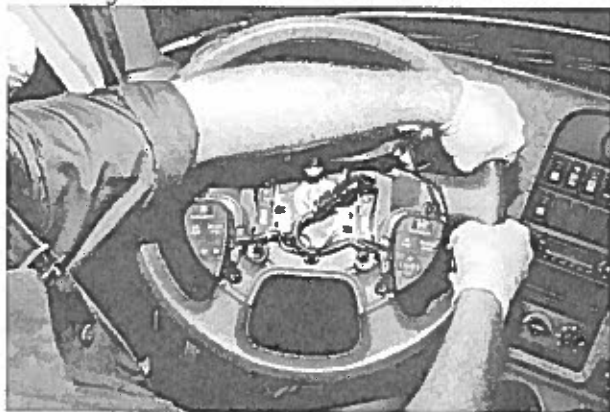
**Figure 2**

2. Place both hands on the right side of the steering wheel, at approximately the 3 O'clock position. Refer to figure 2.

3. Pull up firmly on the steering wheel while noticing any movement. With sustained firm pulling, a properly welded steering wheel should feel solidly attached.
4. Place both hands at the 9 O'clock position. Pull up firmly on the steering wheel while noticing any movement. With sustained firm pulling, a properly welded steering wheel should feel solidly attached.

6. If a small gap opens between the center hub and the outer ring on either side, immediately have the vehicle towed to the nearest authorized International Truck Dealership for further inspection and repair (Figure 3). If there is no movement as a result of step 3 (Figure 4), drive vehicle to the nearest International Truck Dealership, for a more detailed steering wheel inspection.

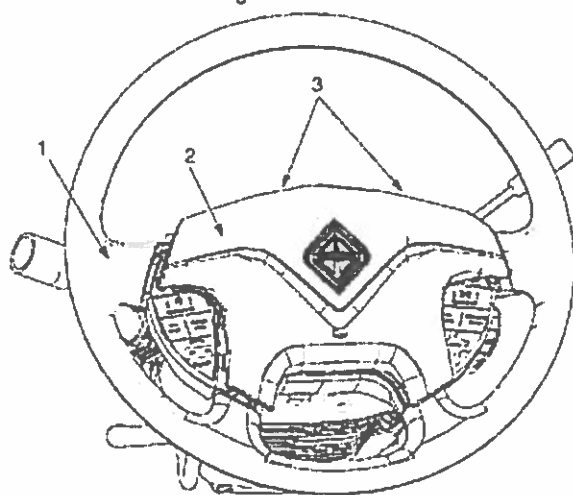
**Figure 1**  
 1 Volant  
 2 Coussin d'avertisseur sonore  
 3 Rebord supérieur

1. Déposez le coussin d'avertisseur sonore en plaçant vos deux mains au-dessus du coussin et en utilisant vos bouts de doigts sous le rebord supérieur du coussin pour tirer délicatement vers le haut dans votre direction. Il n'est pas nécessaire de retirer les connecteurs électriques du coussin d'avertisseur sonore. Voir Figure 1.

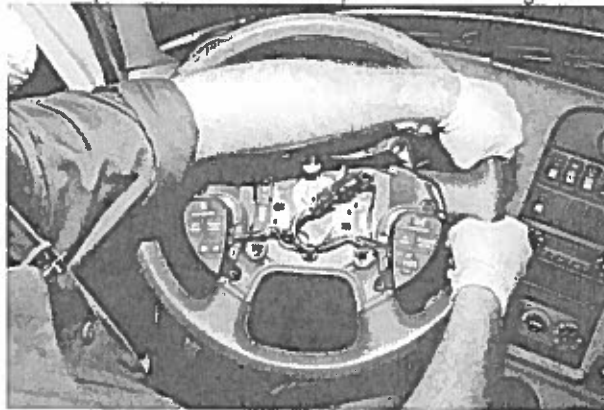
**Figure 2**

2. Placez vos deux mains du côté droit du volant, à la position trois heures. Reportez-vous à la figure 2.

3. Tirez fermement sur le volant et observez si un jeu est présent. Si le volant est correctement soudé, vous devez sentir qu'il est solidement fixé.
4. Placez vos deux mains à la position neuf heures. Tirez fermement sur le volant et observez si un jeu est présent. Si le volant est correctement soudé, vous devez sentir qu'il est solidement fixé.
