GROUP Campaign	MODEL 2007/08MY Rondo (UN), 2006/08 Optima (MG)
	NUMBER 094	DATE February 2012
<b>SAFETY RECALL CAMPAIGN</b>		
SUBJECT: RONDO & OPTIMA CLOCK SPRING ASSEMBLY REPLACEMENT (SC094)

Rondo & Optima Clock Spring Assembly

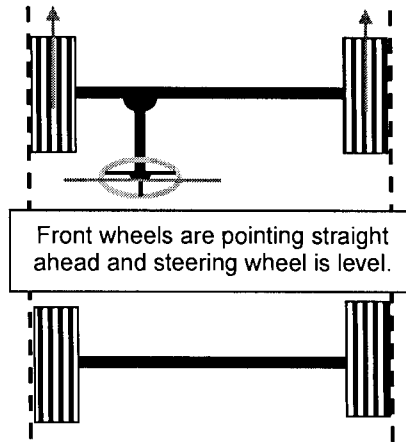
1. Drive vehicle into the shop and make sure the front wheels are pointing straight ahead and the steering wheel is straight and level before performing the service procedure.

Front wheels and steering wheel must be straight to ensure proper installation of the clock spring assembly.
