GROUP Campaign	MODEL 2007/08MY Rondo (UN), 2006/08 Optima (MG)
	NUMBER 094	DATE February 2012
SAFETY RECALL CAMPAIGN		
SUBJECT: RONDO & OPTIMA CLOCK SPRING ASSEMBLY REPLACEMENT (SC094)

Rondo & Optima Clock Spring Assembly

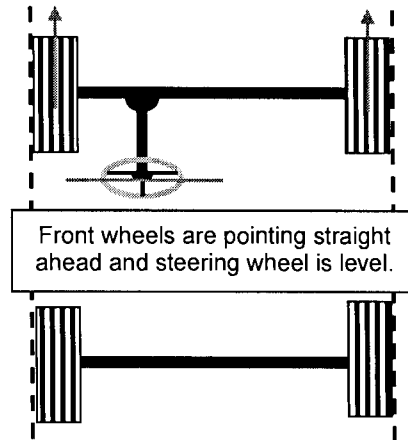
Front wheels and steering wheel must be straight to ensure proper installation of the clock spring assembly.

1. Drive vehicle into the shop and make sure the front wheels are pointing straight ahead and the steering wheel is straight and level before performing the service procedure.
