Audi

# Safety Recall

Code: 60B2

**Subject: 2012 Model Year Audi Q5 with Sunroof Glass Panel  
Front Sunroof Glass Panel**

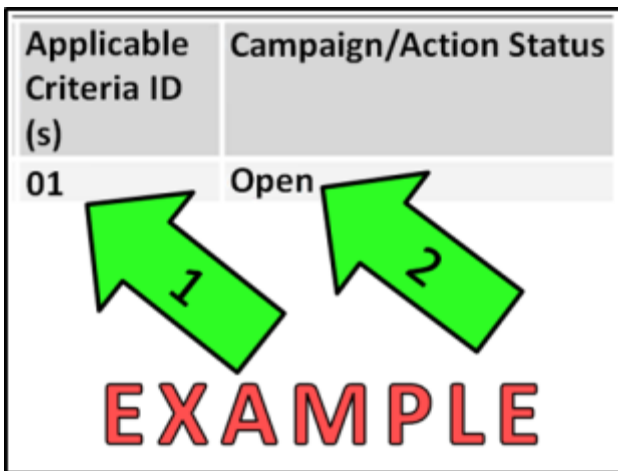
← Ensure that the Status is "Open" <arrow 2>.

- Note the Applicable Criteria ID for use in determining the correct work to be done and corresponding parts associated <arrow 1>.
- Continue to **Section B**.
